Dunlap Lake Watershed Study and Lake Management Plan

(prepared for the Dunlap Lake POA)

(Draft Submittal – 1/26/05)

Cochran & Wilken, Inc.

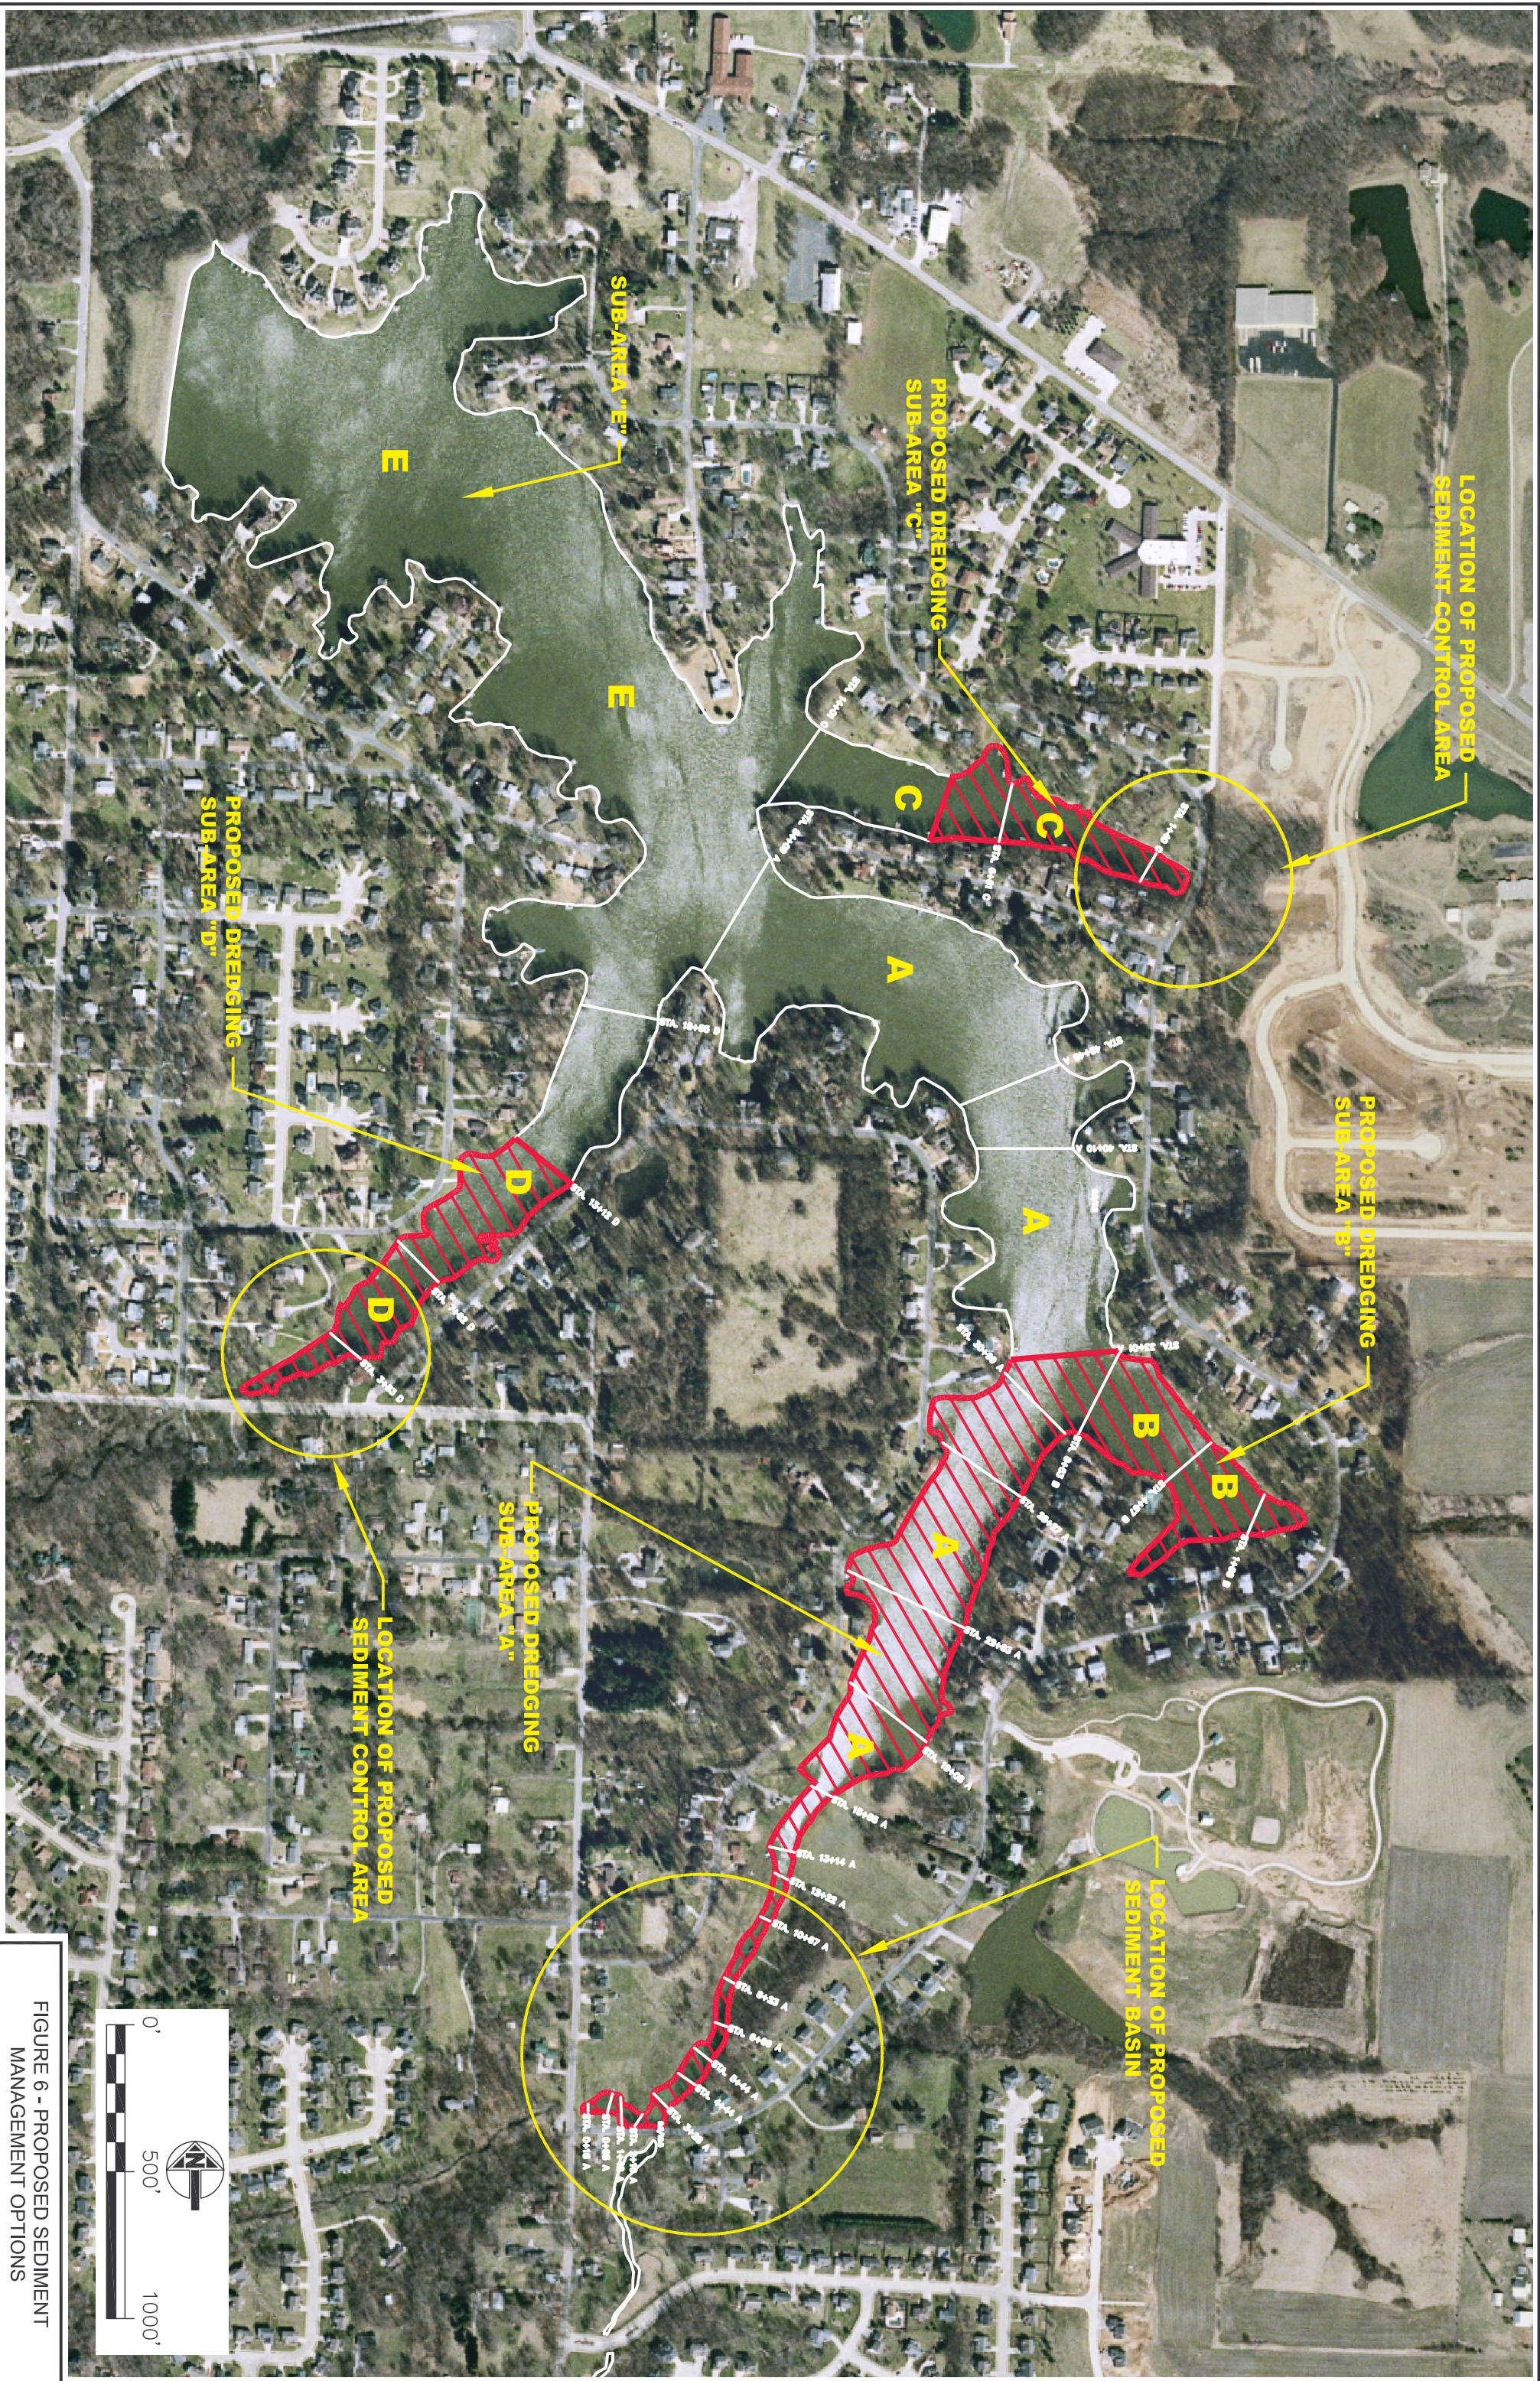
FIGURE 6 - PROPOSED SEDIMENT MANAGEMENT OPTIONS

The greatest percentage of sediment deposition has occurred at the south end of the lake where the primary tributaries or feeder streams enter from the relatively large drainage area (2,000 acres) of sub-watersheds A-1, A-2, A-3, A-4, A-5, and B-1. Within the impacted section of sub-area "A" (segments 1 – 18), approximately 89,296 cubic yards or approximately 44.9 percent of the original water storage capacity has been lost to accumulated sediment (See Table 3). The degree of impact from sediment deposition in sub-area "A" is relatively continuous throughout lake segments 1 through 18, which begins near the intersection of Gerber Road and East Lake Road and extends past the mouth of sub-area "B". The vast extent of accumulated sediment in sub-area "A" of the lake is not unexpected considering the narrow riverine channel morphology, which allows high flow velocities to carry fine-grained suspended sediment far into the main body of the lake. If the gradual historical loss of lake storage volume and water depth is not corrected, by implementing sediment management measures such as sediment load reduction and sediment removal, additional water storage capacity will likely be lost as sediment deposition continues to prograde further north into the main body of the lake.

In addition to the recommended sediment removal requirements described above, sediment management measures should also include efforts to minimize the volume of suspended sediment entering the lake so that the benefits of any sediment removal efforts are longer lasting (see Figure 6). As discussed earlier in the report, the DLPOA requested support from the local NRCS District Engineer to design a suitably sized sediment basin to effectively trap and control excessive sediment loads entering the lake from the south end.

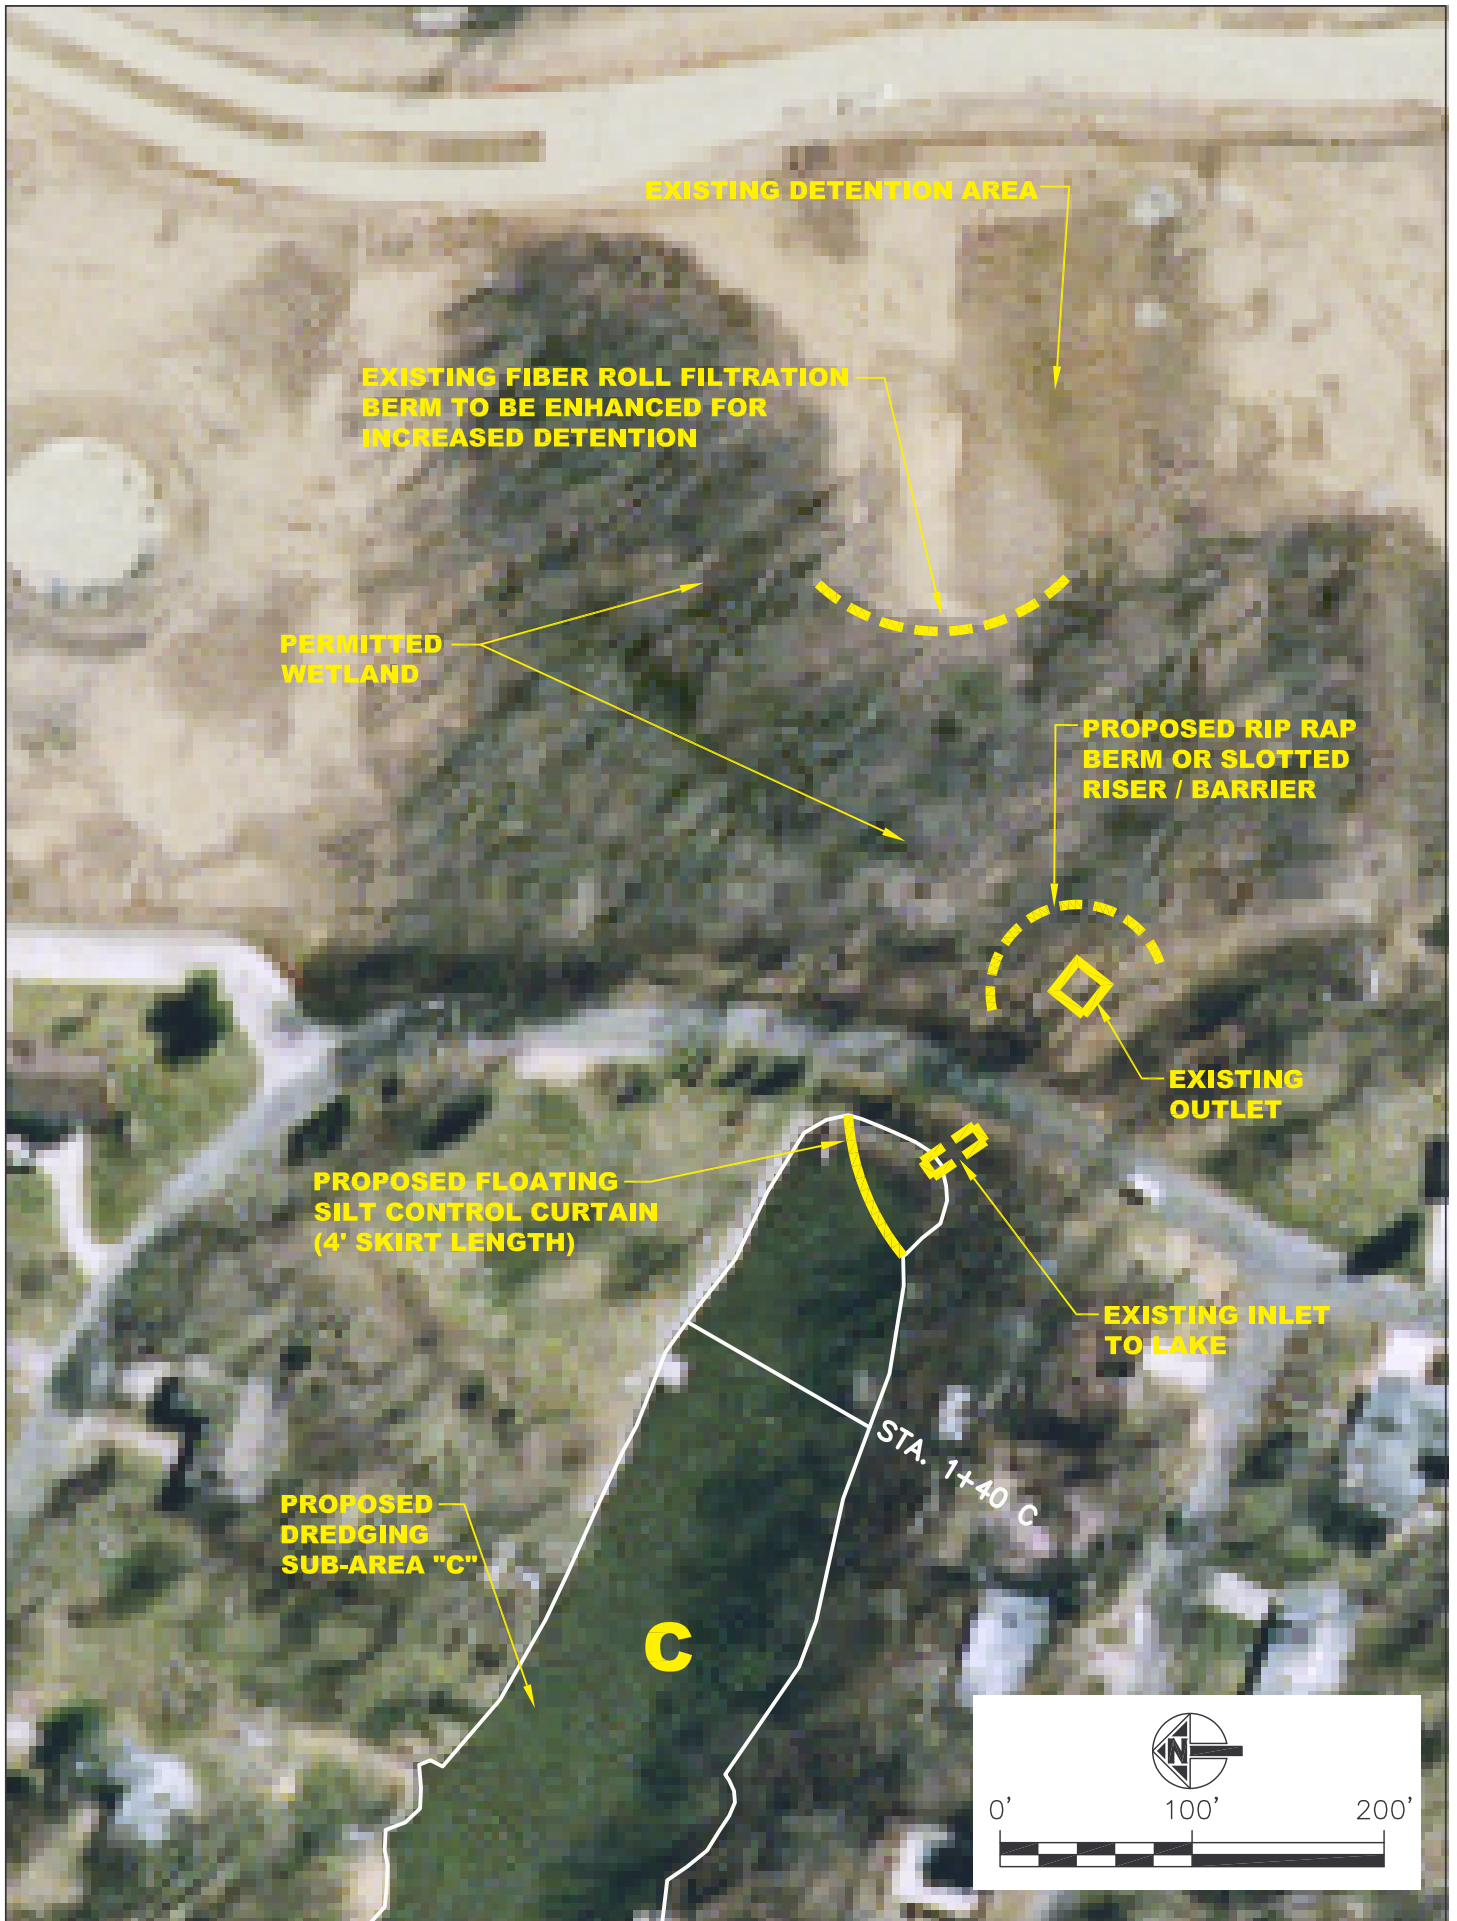
FIGURE 8. SEDIMENT REDUCTION OPTIONS – AREA C

The recent development of the Oaks subdivision within the sub-watershed C-1 has been an issue of concern for the DLPOA. Prior to development of the subdivision, the local developer was required to submit engineering plans to control storm water runoff and obtain a construction permit under the City of Edwardsville's (City) Erosion Control Ordinance (ordinance). In order to reduce the impacts from storm water runoff, the developer prepared engineering plans for a 0.50-acre detention basin and a multi-tiered concrete detention basin outlet structure between Redwood Drive and East Lake Drive. These structural BMPs were intended to collect and control storm water runoff and detain it until the storm water or runoff could be discharged at a reduced rate to minimize the impacts to Dunlap Lake. The location of the detention basin was located between a 1.19-acre wetland, which triggered another set of permitting requirements. The developer subsequently submitted engineering plans and a Section 404 permit application to the St. Louis District of the U.S. Army Corps of Engineers (COE) to construct the detention basin and outlet structure near or within the regulated wetland. The COE approved the permit application and issued permit #200104780. As part of the permit requirement, it was stated that storm water flow to the wetland could not be prevented or reduced.

During normal flow conditions and after light to moderate precipitation events (i.e. one quarter on an inch or more of rain), turbid storm water runoff has been observed "short-circuiting" or flowing through the detention basin and the wetland, and into the lower culvert pipe opening of the outlet structure, which discharges directly into sub-area "C" of Dunlap Lake. The DLPOA recognizes that the existing detention basin and outlet structure were a good faith effort to control storm water runoff and that no storm water BMP is completely effective in reducing all impacts from runoff. However, enhancements could be made to the existing detention basin and outlet structure that would improve storm water detention and sediment trapping efficiency (see Figure 8). These enhancement efforts would likely be funded and completed by the DLPOA, and would require City and COE permit modifications. However, an improved and cooperative relationship between the DLPOA and the local developer, and the City would be required.

The bottom invert for the lower-most intake on the detention basin outlet structure is at or near the bottom elevation of the wetland, which causes the run-off to “short-circuit” through the wetland without any additional temporary detention. A slotted, vertical riser could be retrofitted to the lower-most intake on the detention basin outlet structure that would allow runoff to discharge to Dunlap Lake at a reduced rate. This minor modification would temporarily detain storm water to allow sediment to settle out via gravity and reduce the sediment loads to Dunlap Lake. The small slotted openings in the riser (2 to 3 feet in height) would slowly release the storm water.

Another potential outlet structure modification is a small riprap berm or slotted corrugated metal barrier (two to three feet high) around the bottom invert for the lower-most intake on the detention basin outlet structure. This modification would allow flow to pass through at a reduced rate, while filtering sediment and providing additional detention time.

These low technology and relatively low cost modifications to the detention basin, wetland, and outlet structure may slightly alter the hydraulics of the system, and if implemented, this issue would need to be addressed and considered within a permit

modification submitted to the COE. We estimate that modifications as described above could be designed, permitted and installed for \$5,000 to \$8,000 pending landowner and City approval.

The most feasible BMPs to implement are those located on DLPOA owned land. A floating curtain or barrier could be installed within sub-area “C” of Dunlap Lake near the culvert that discharges runoff from the Oaks detention basin outlet structure. This “turbidity curtain” would help diminish flow velocities and would enhance sediment deposition to be confined in a localized area near the culvert. Attached at the shoreline, the curtain would extend across the water’s surface and would extend downward and anchored to a depth of approximately one to two feet off the bottom.

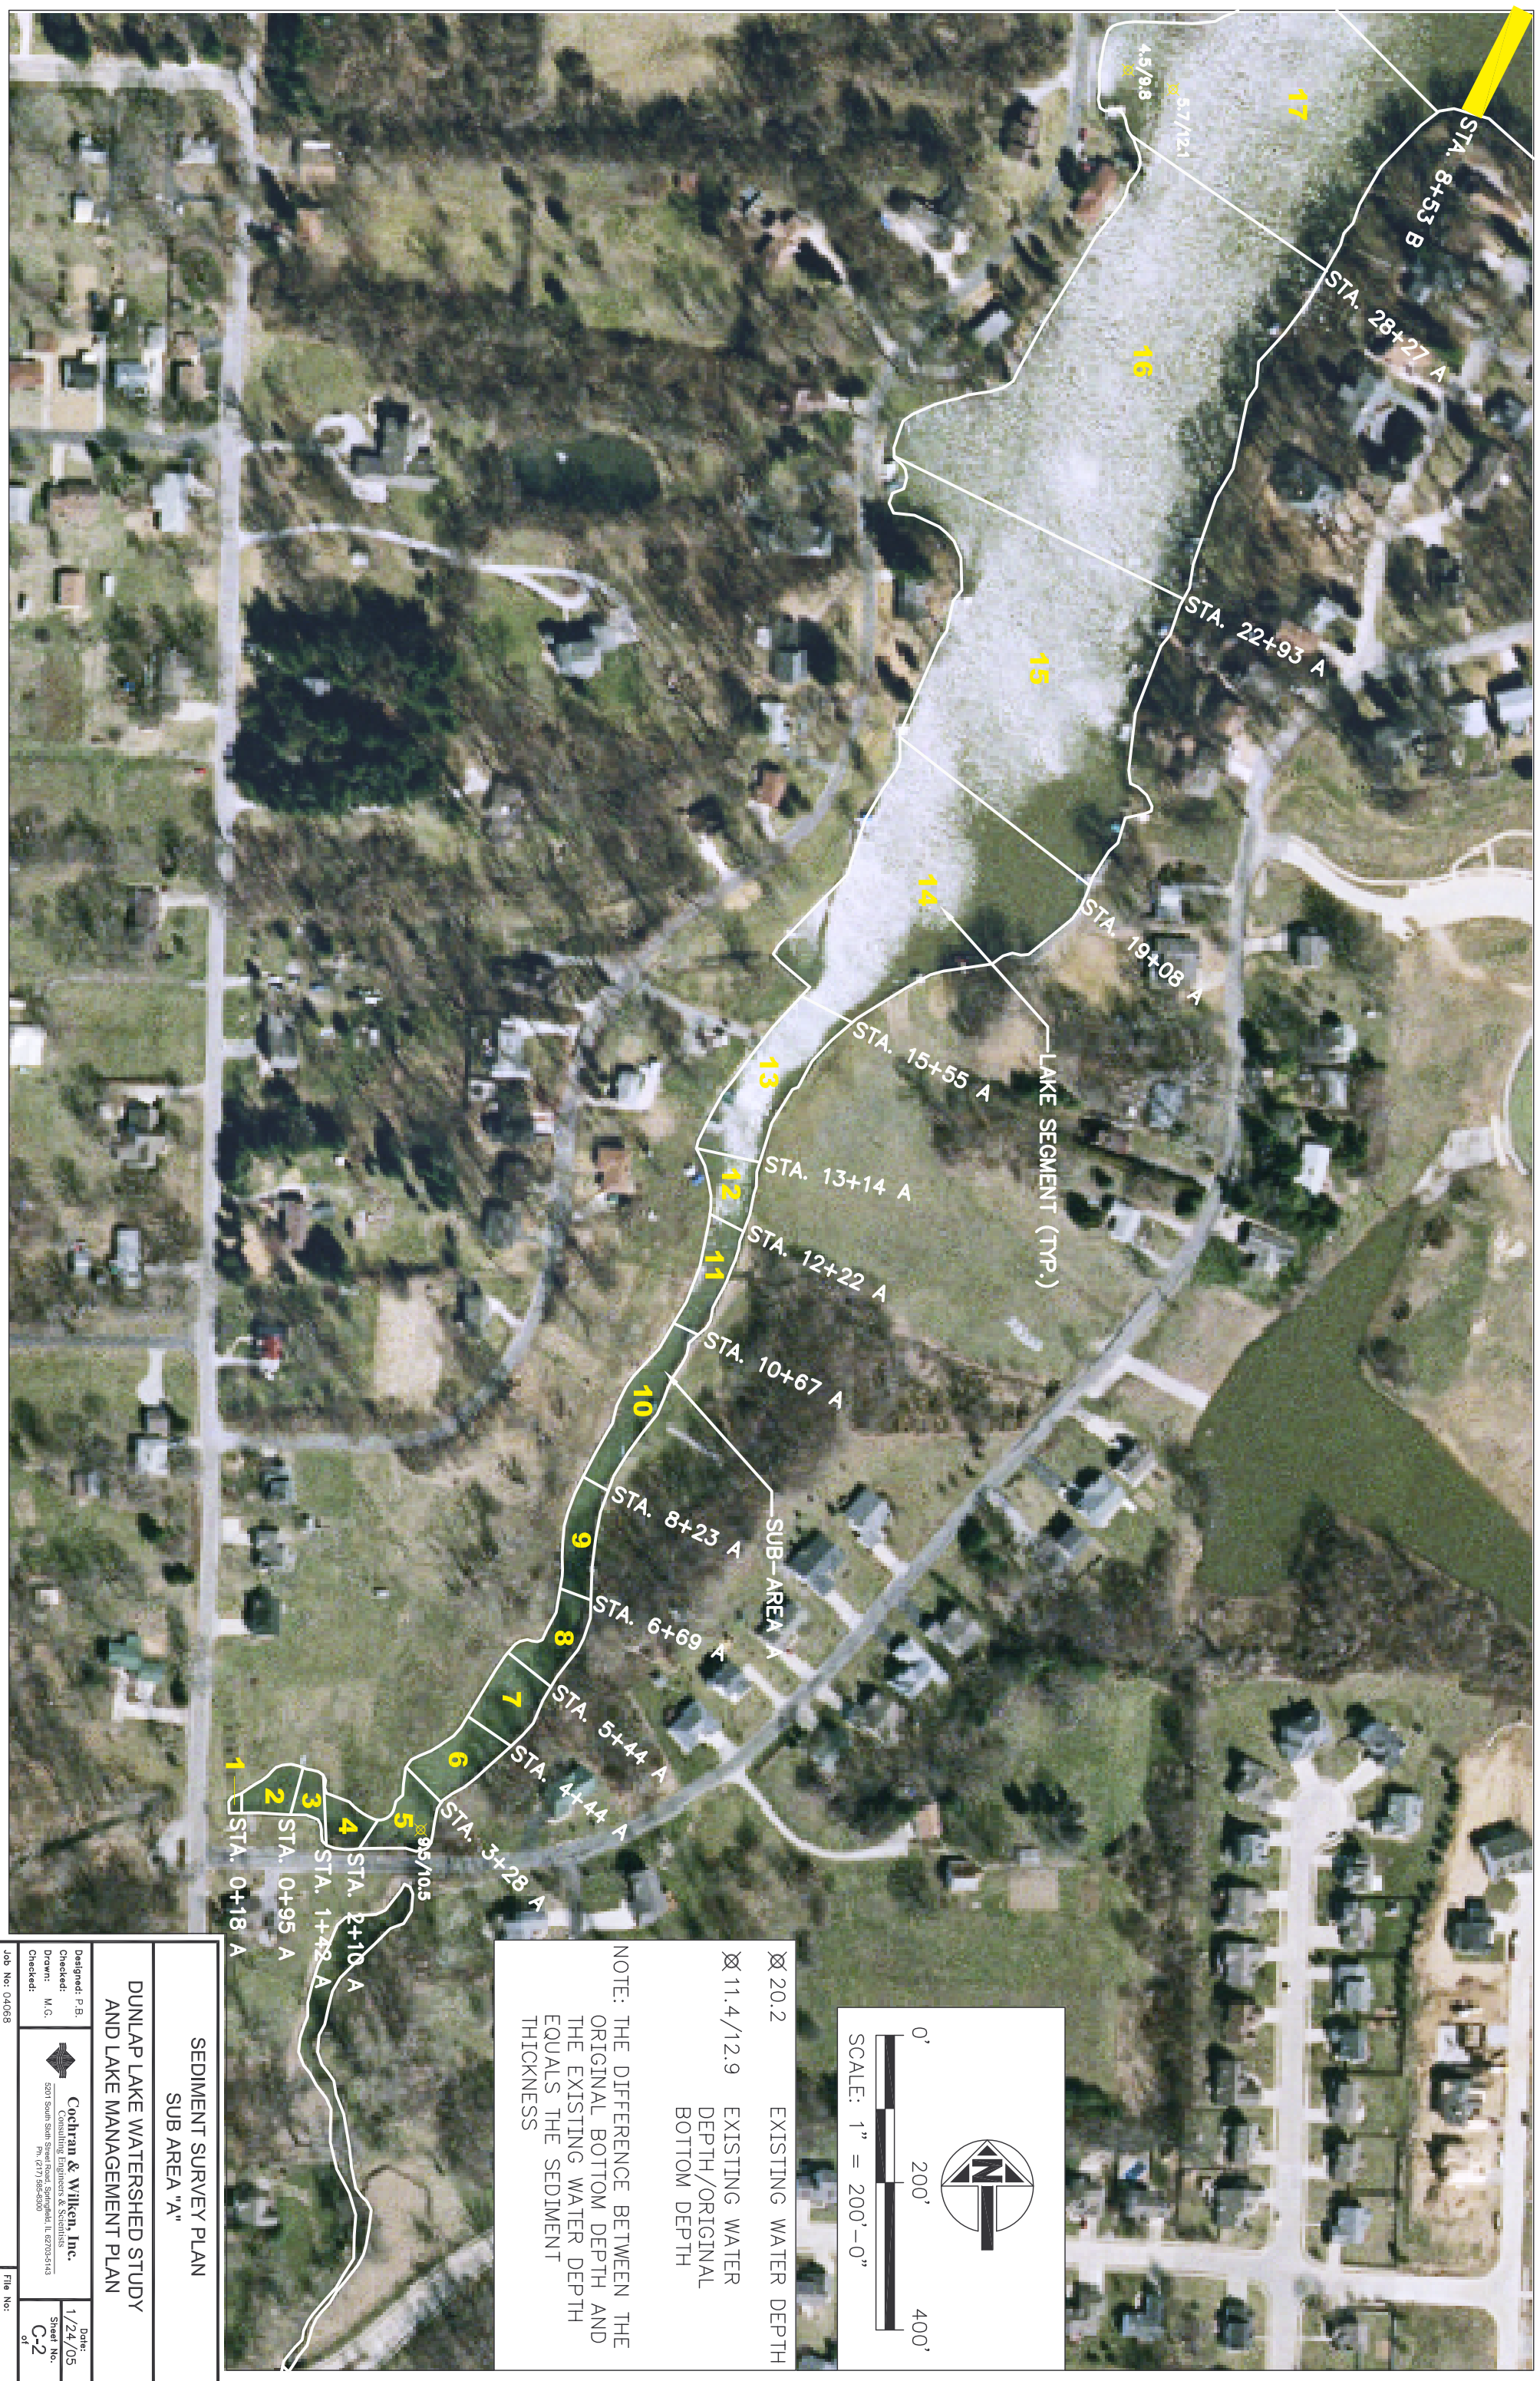
Sub-area “A” is located at the south end of Dunlap Lake where the main tributaries to the lake enter and continues into the main body of the lake. This sub area was found to have a total of 204,523 cubic yards of accumulated sediment, which represents 34% of its original water storage capacity. Upland land use areas that drain into sub-area “A” include agriculture, existing urban/residential, woodland, and urban/residential under construction or development.

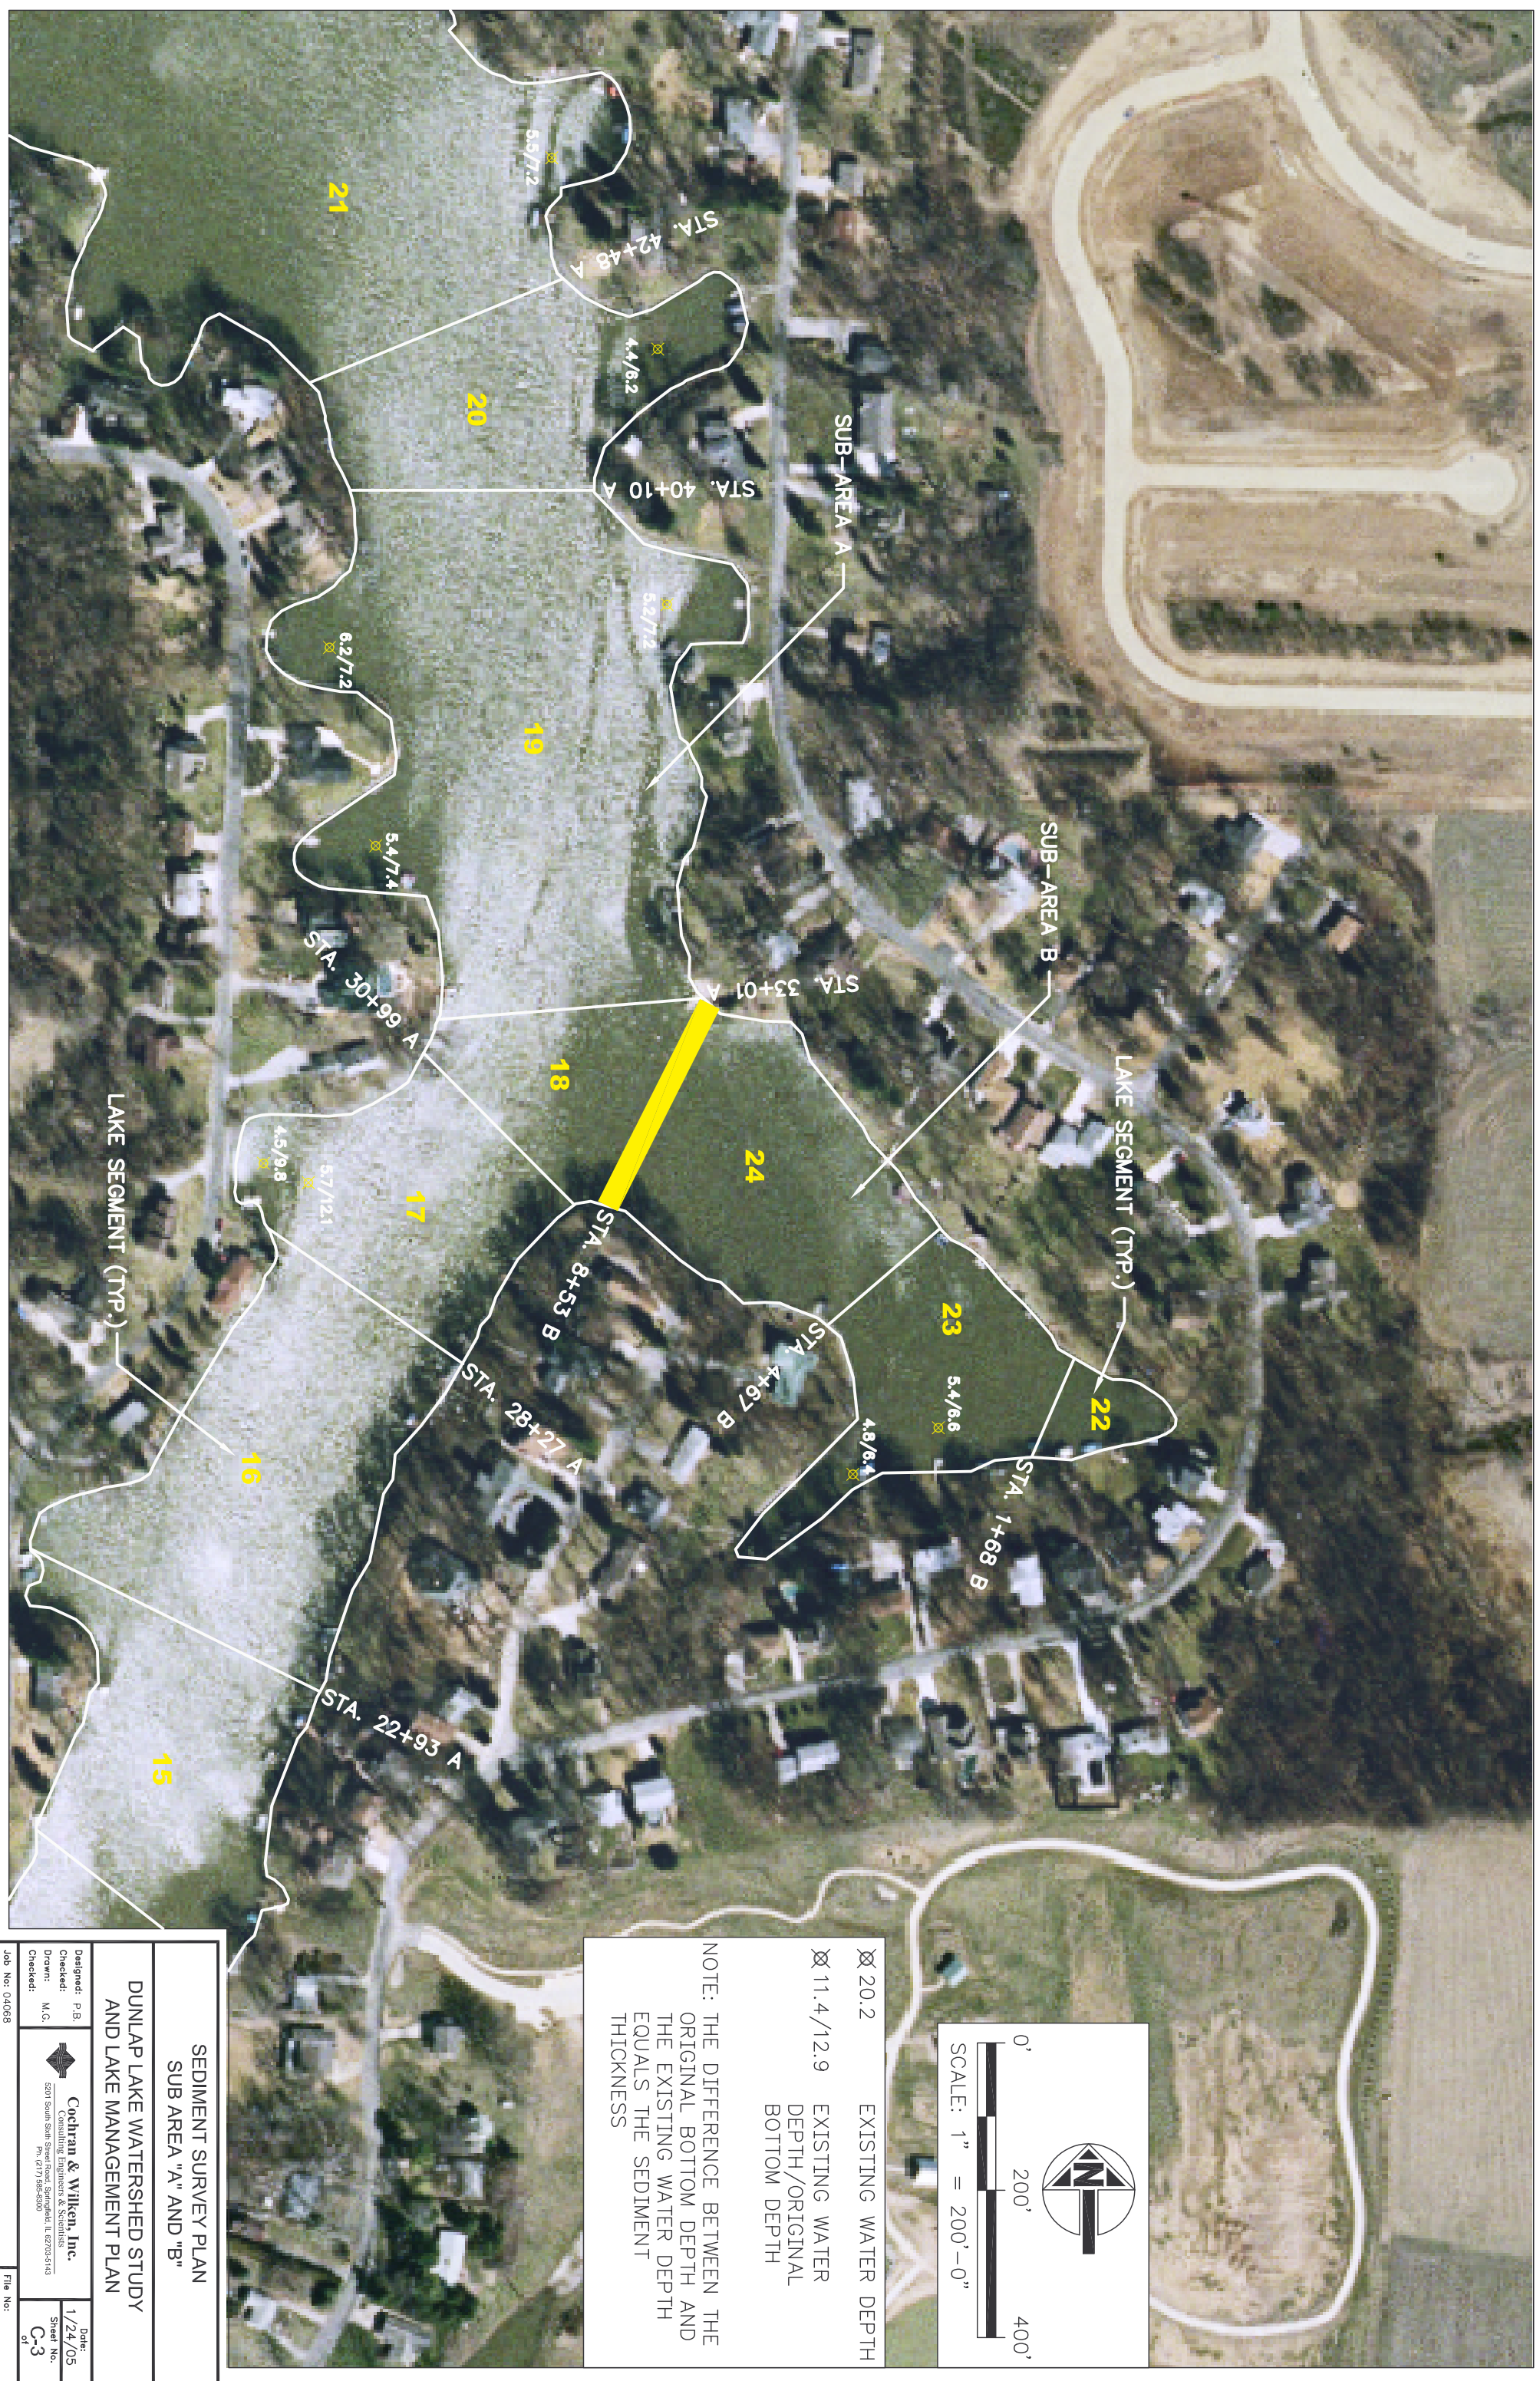
Sub-area “B” is located on the southeast side of the lake and was found to have approximately 12,086 cubic yards of accumulated sediment, which represents 28.6% of its original water storage capacity. The loss of capacity in the individual segments of sub-area “B” ranged from a high of 31.5% to a low of 16.8%, with the most significant sediment deposition occurring near the main portion of the lake (closest to sub-area “A”). Upland land use areas that drain into sub-area “B” include agriculture and residential land uses.

The impacted area of sub-area "B" or the east bay located near the south end of the lake extends the entire 850 feet of the inlet. This small bay at the southeast end of the lake connects to the main body of the lake (sub-area "A") at a point where sediment deposition from sub-area "A" is still significant.

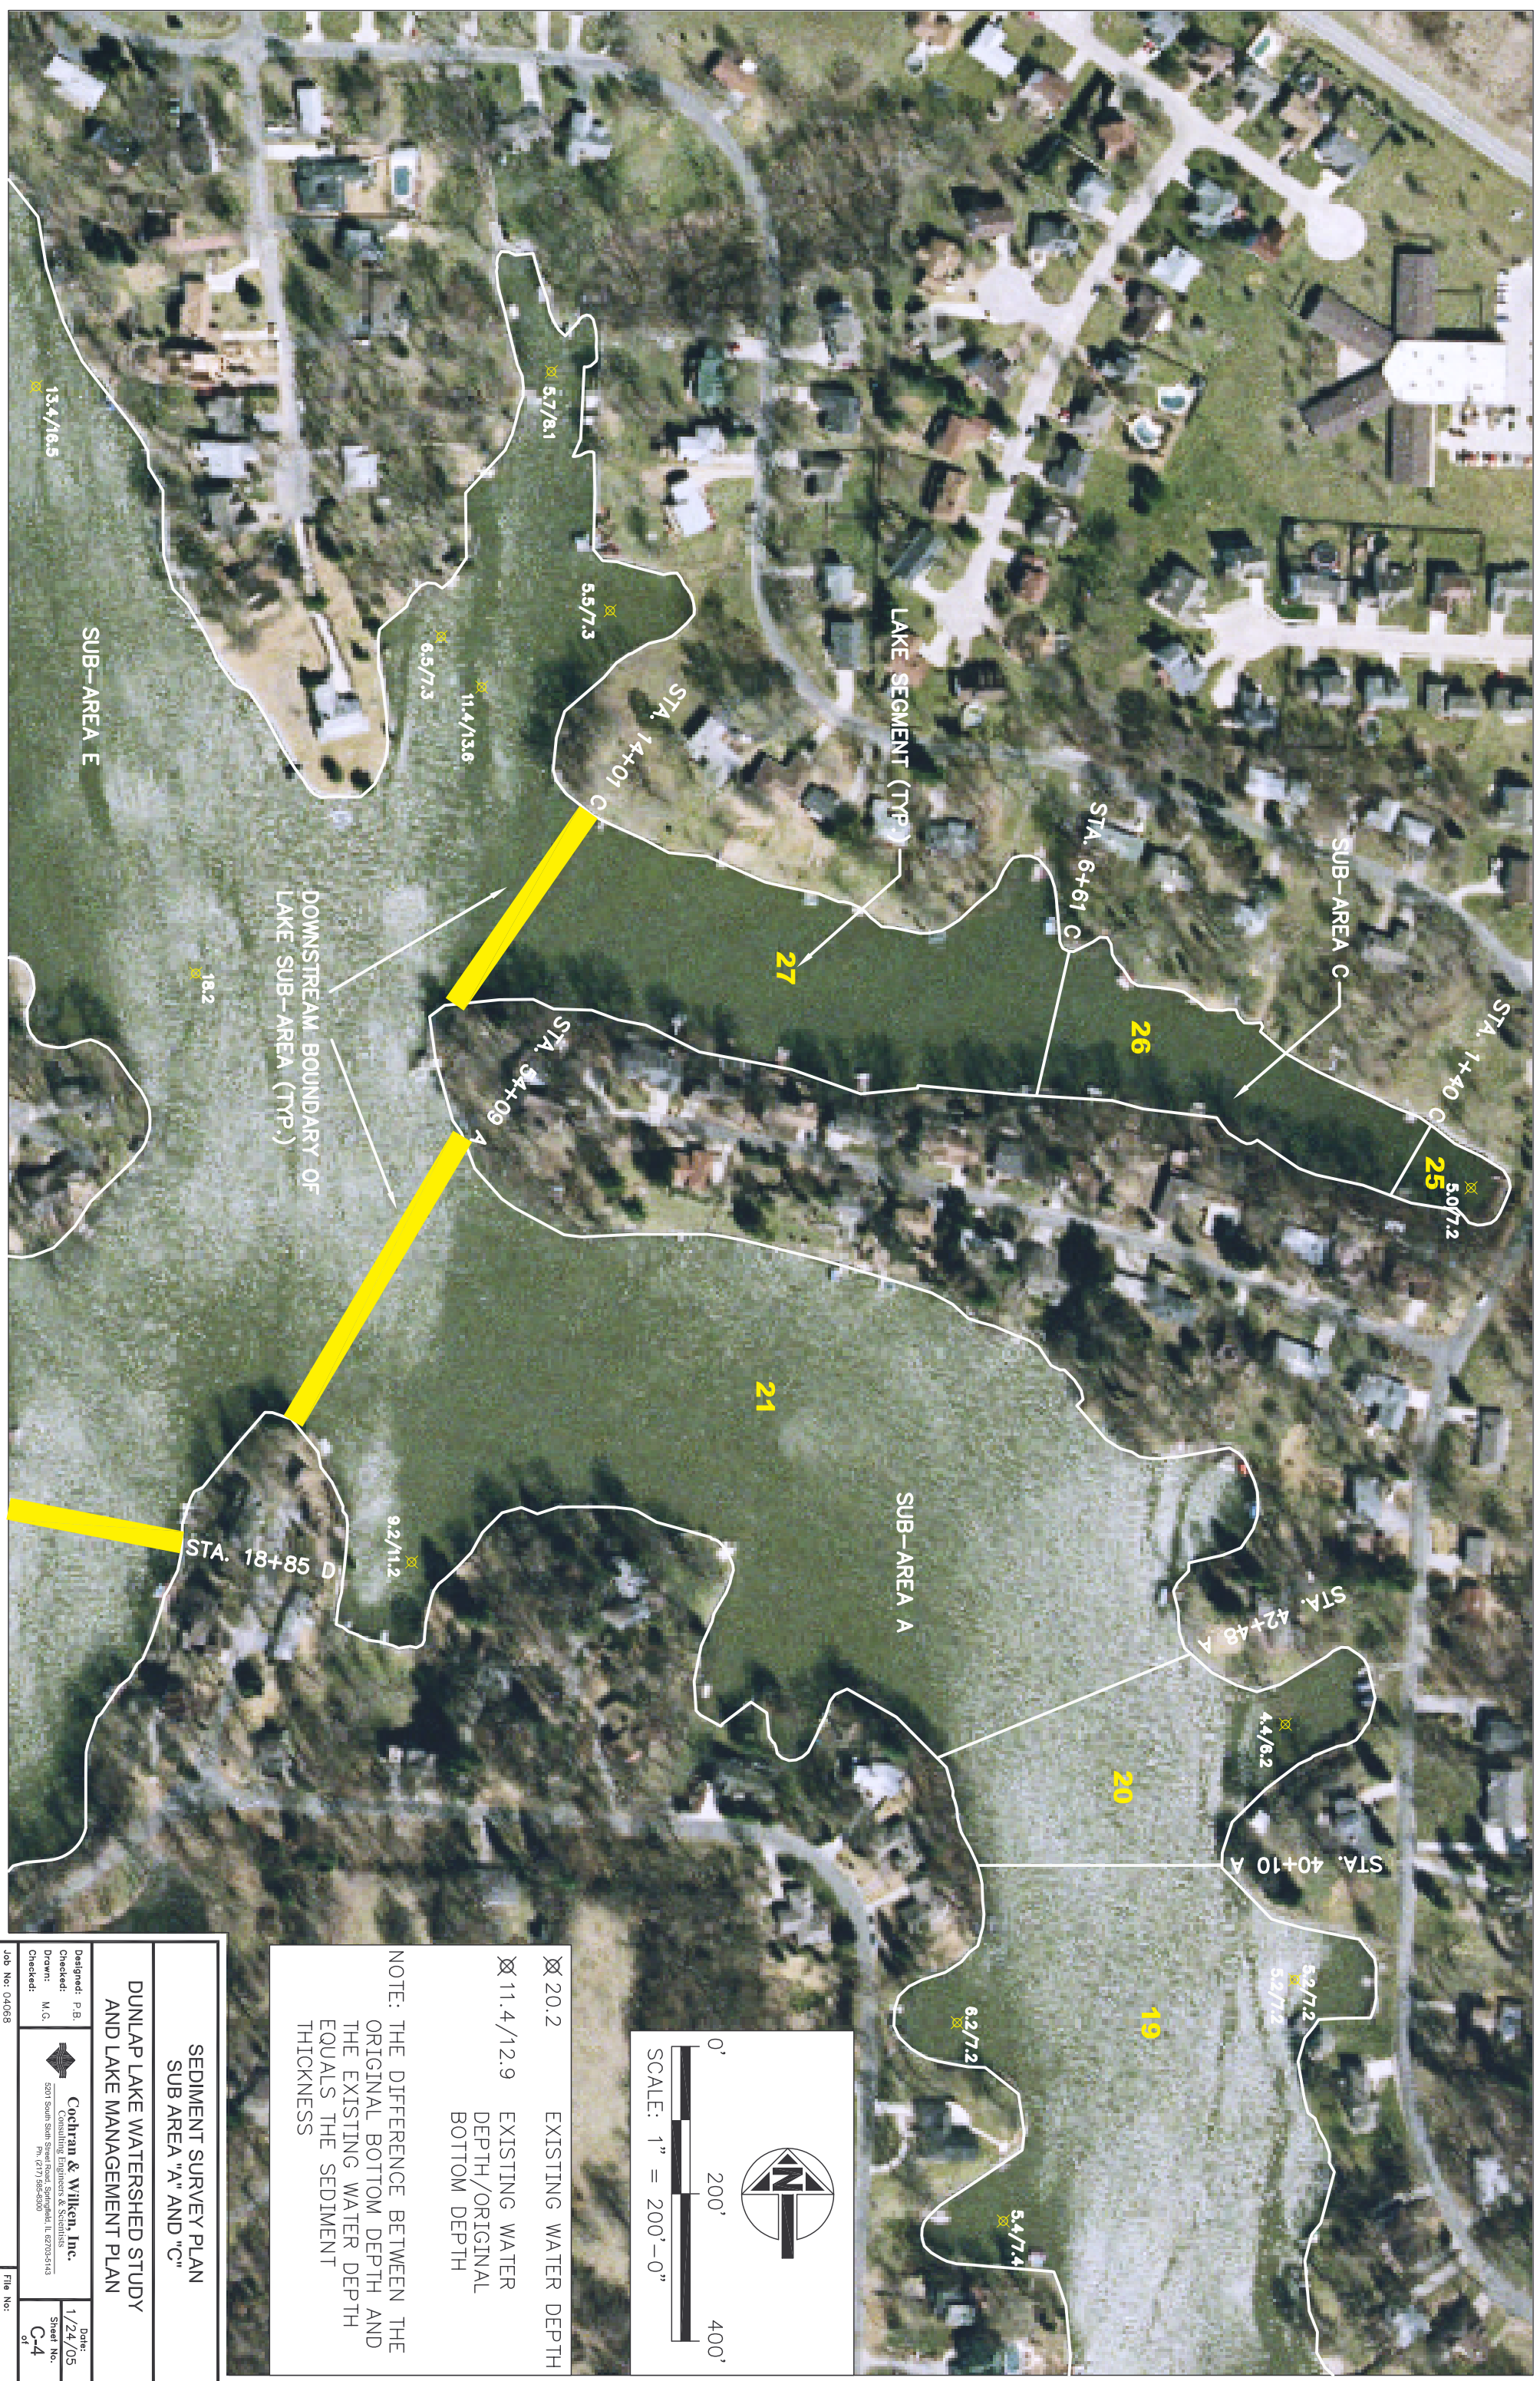
SEDIMENT SURVEY PLAN
SUB AREA "A" AND "C"

The amount of accumulated sediment measured in sub-area “C” was approximately 19,306 cubic yards, which represents a 20.1% loss of original water storage capacity. The capacity loss in the individual segments of sub-area “C” ranged from a high of 25.2% to a low of 18.0%. The land uses in the surrounding sub-watershed that drains into sub-area “C” include agriculture, existing urban/residential, and urban/residential under construction or development.

The C-1 sub-watershed is approximately 92 acres (3.5 percent of the total watershed) and drains into sub-area “C”, which is the east inlet near the north end of the lake. According to the survey cross sections, it was determined that the impacted area in sub-area “C” was limited to lake segments 25 through 26, where approximately 24.7 percent of the original water storage capacity has been lost and 5,456 cubic yards of sediment have been deposited. Since the maximum water depth at Section 06+61C (downstream end of impacted area) was found to range from 7.0 to 9.0 feet with sediment depths of 3.0 to 4.0 feet, it has been estimated that the impacted area extends approximately 200 feet into segment 27. The estimated sediment volume in the partial lake segment 15 is approximately 3,193 cubic yards. Therefore, the total estimated sediment volume in the impacted area of sub-area “C” is 8,648 cubic yards.
