Dunlap Lake Watershed Study and Lake Management Plan

(prepared for the Dunlap Lake POA)

(Draft Submittal – 1/26/05)

Cochran & Wilken, Inc.

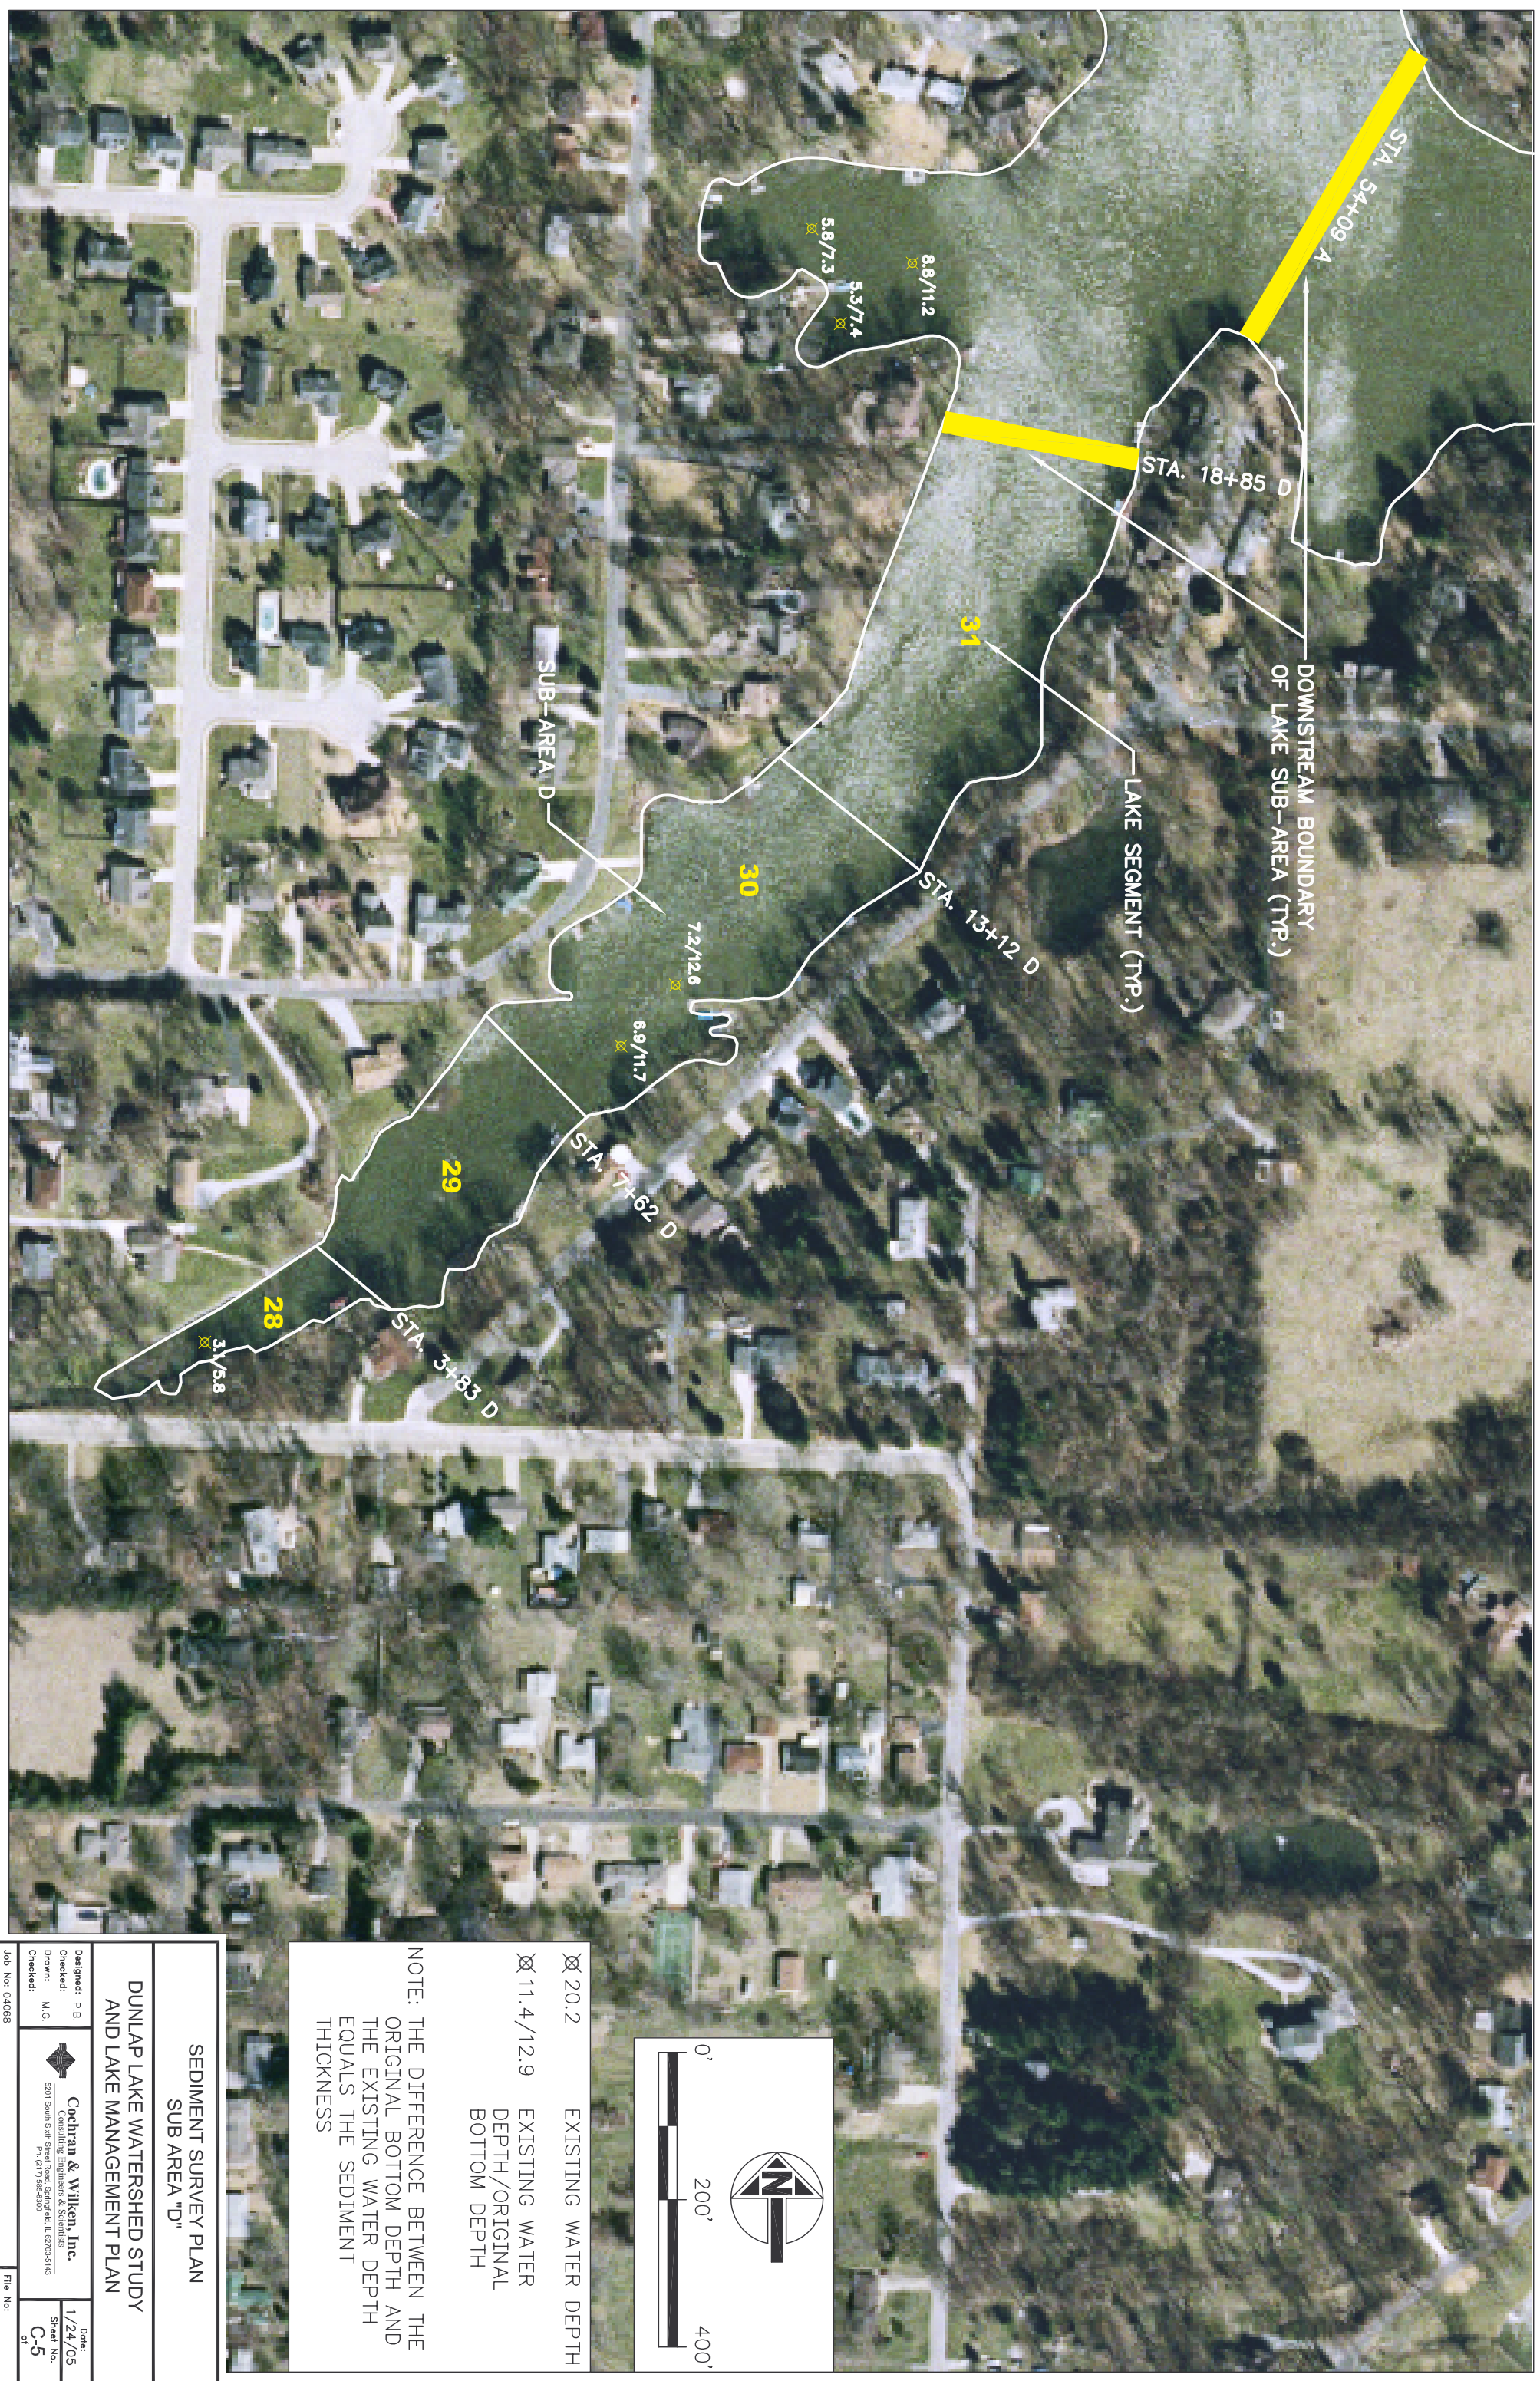
SEDIMENT SURVEY PLAN
SUB AREA "D"

Sub-area “D” is a long narrow bay located near the northwest side of the lake. The sedimentation survey indicated that this sub-area has experienced an estimated loss of 27.9% of its original water storage capacity and was found to have approximately 25,635 cubic yards of sediment deposited within the measured survey transects. The sub-area “D” watershed receives runoff water from existing urban and residential areas.

Sub-watershed D-1 drains 327 acres (12.5 percent of the total watershed) into the west inlet or sub-area “D” of the lake. The sediment survey cross sections indicate that the impacted area has been confined to lake segments 28 through 30, which have lost 29.2 percent of their original water storage capacity and approximately 15,851 cubic yards of sediment has been deposited.

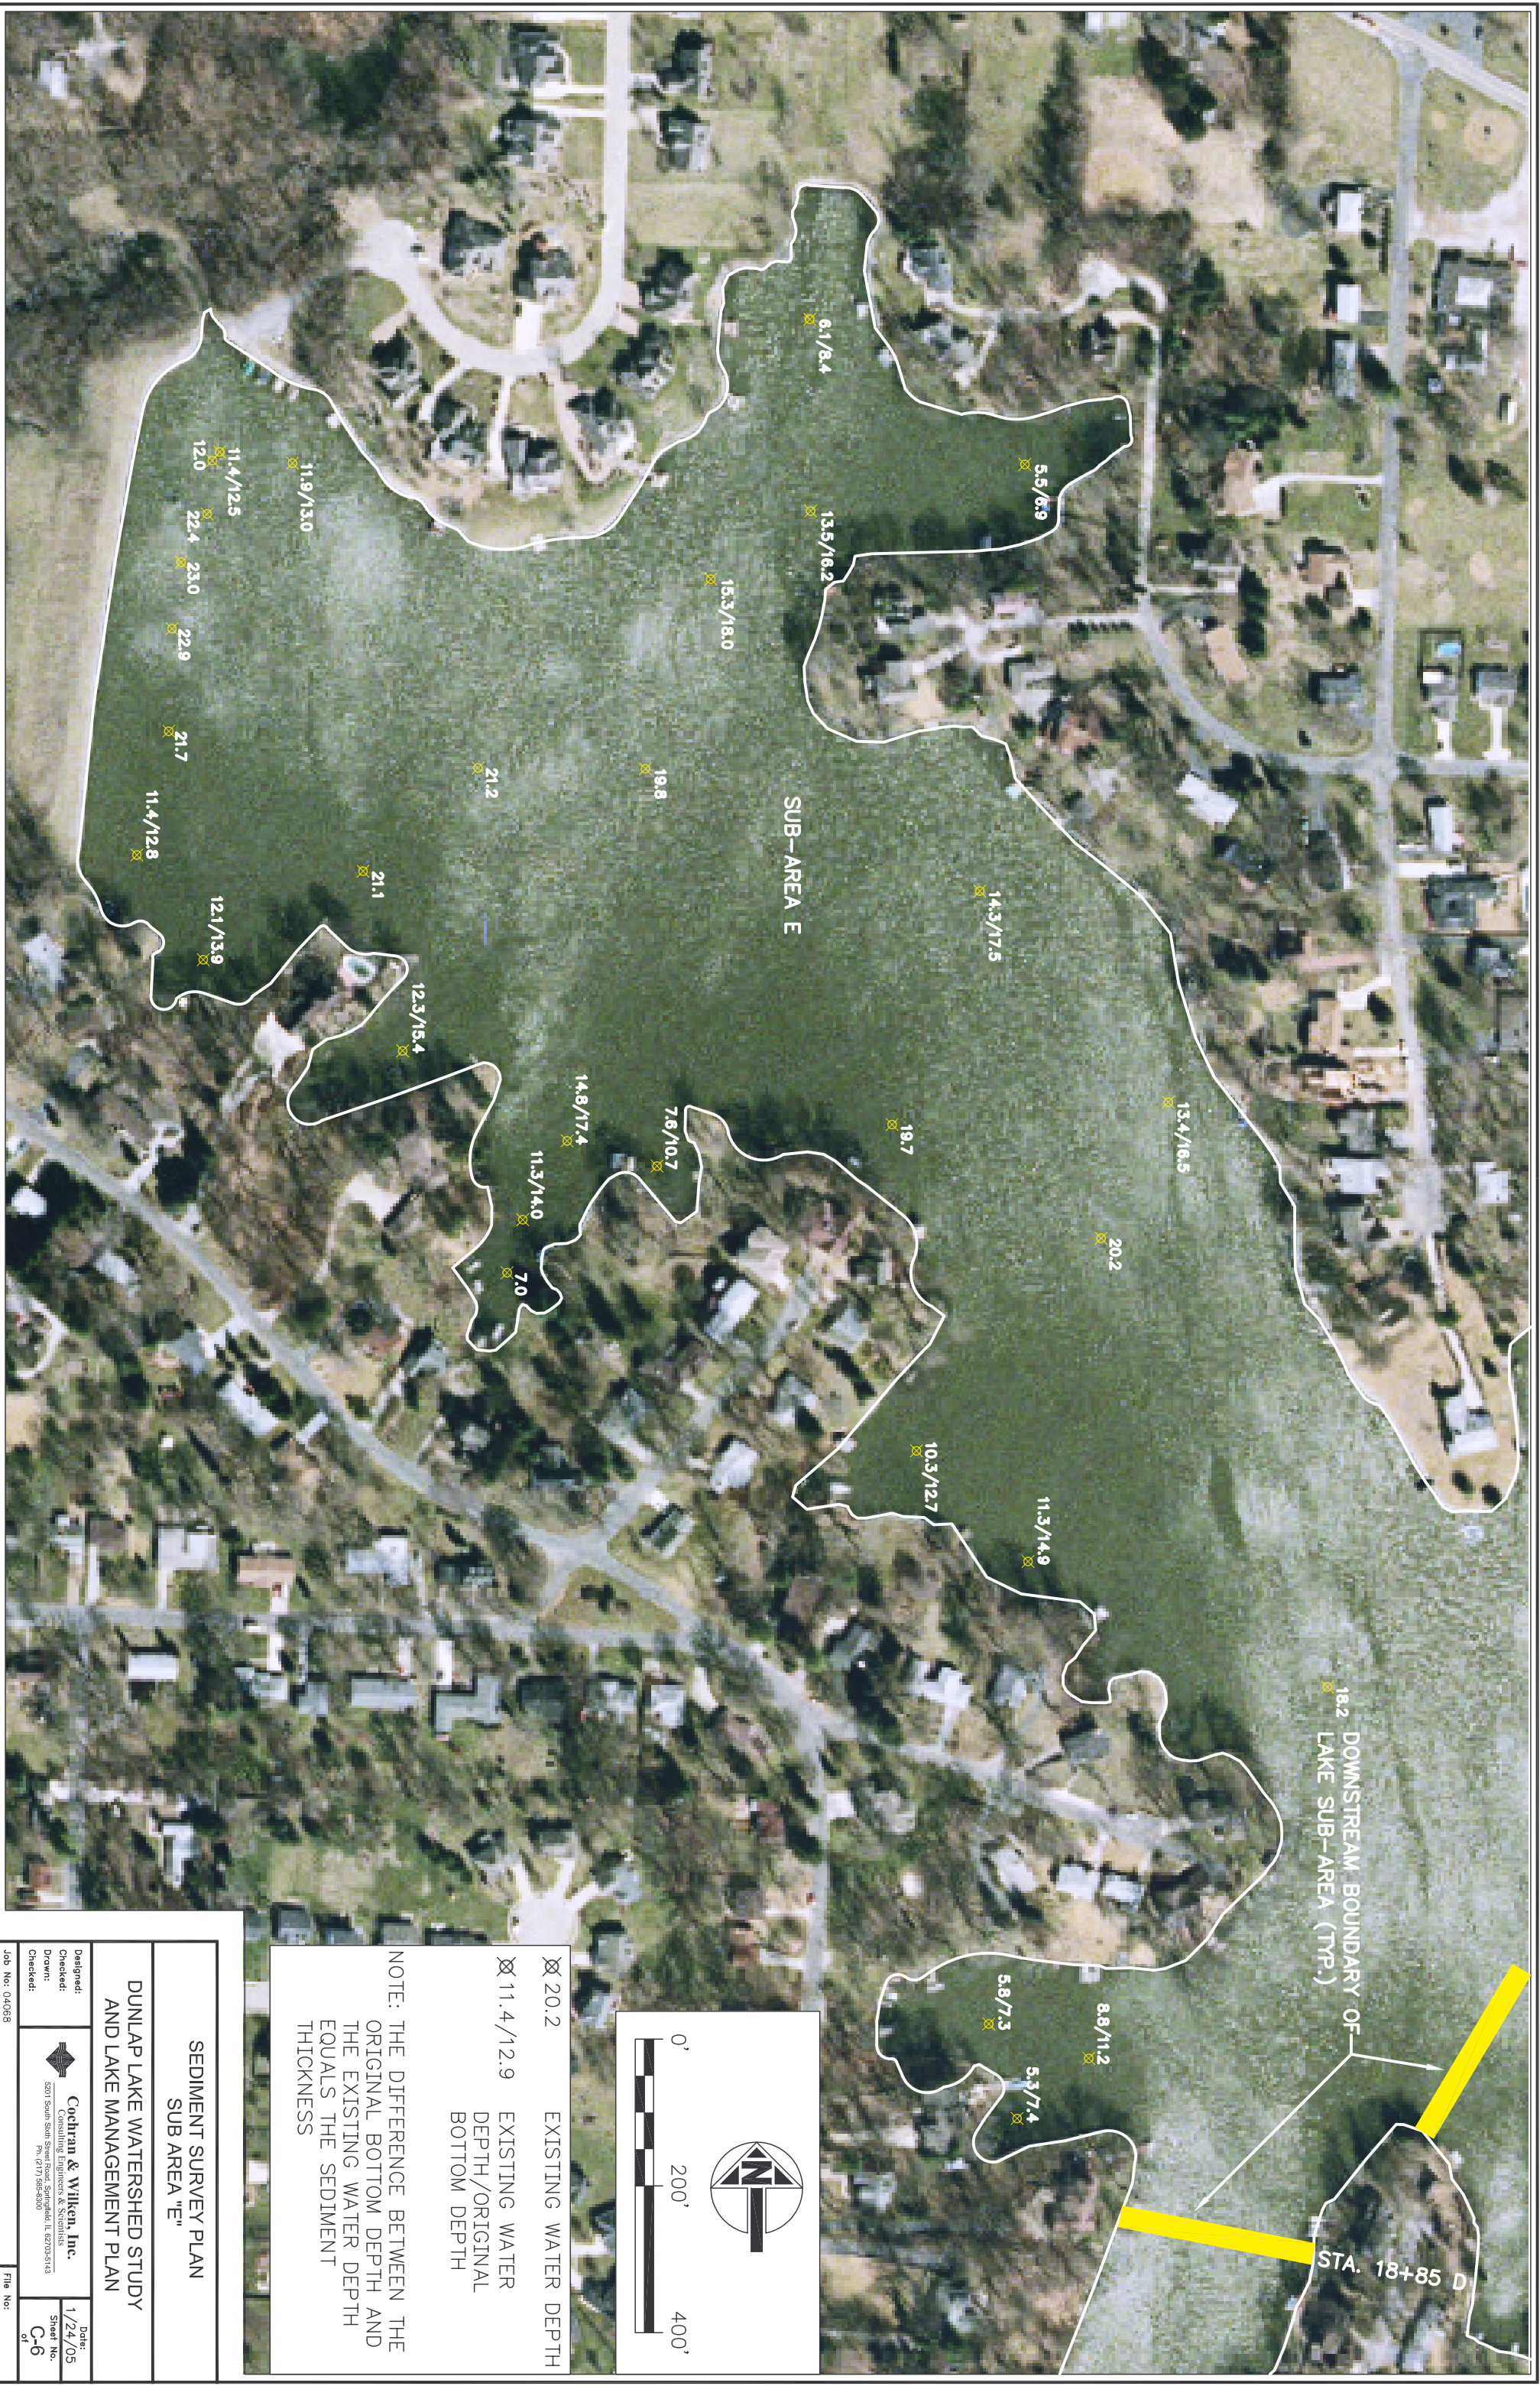
SEDIMENT SURVEY PLAN
SUB AREA "E"

The sedimentation survey included random points within the smaller inlets at the north end of Dunlap Lake and depth to bottom measurement near the dam. While these northern most inlets contained some sediment, they did not appear to have the levels of sediment deposition and subsequent capacity loss as lake sub-areas “A through D.” The random deep-water measurements indicated that the existing maximum depth is approximately 23 feet. Since sediment accumulations ranged from 1.1 to 1.8 feet in and around the area of the dam and spillway, it is estimated that the original maximum depth of the lake was approximately 25 feet.

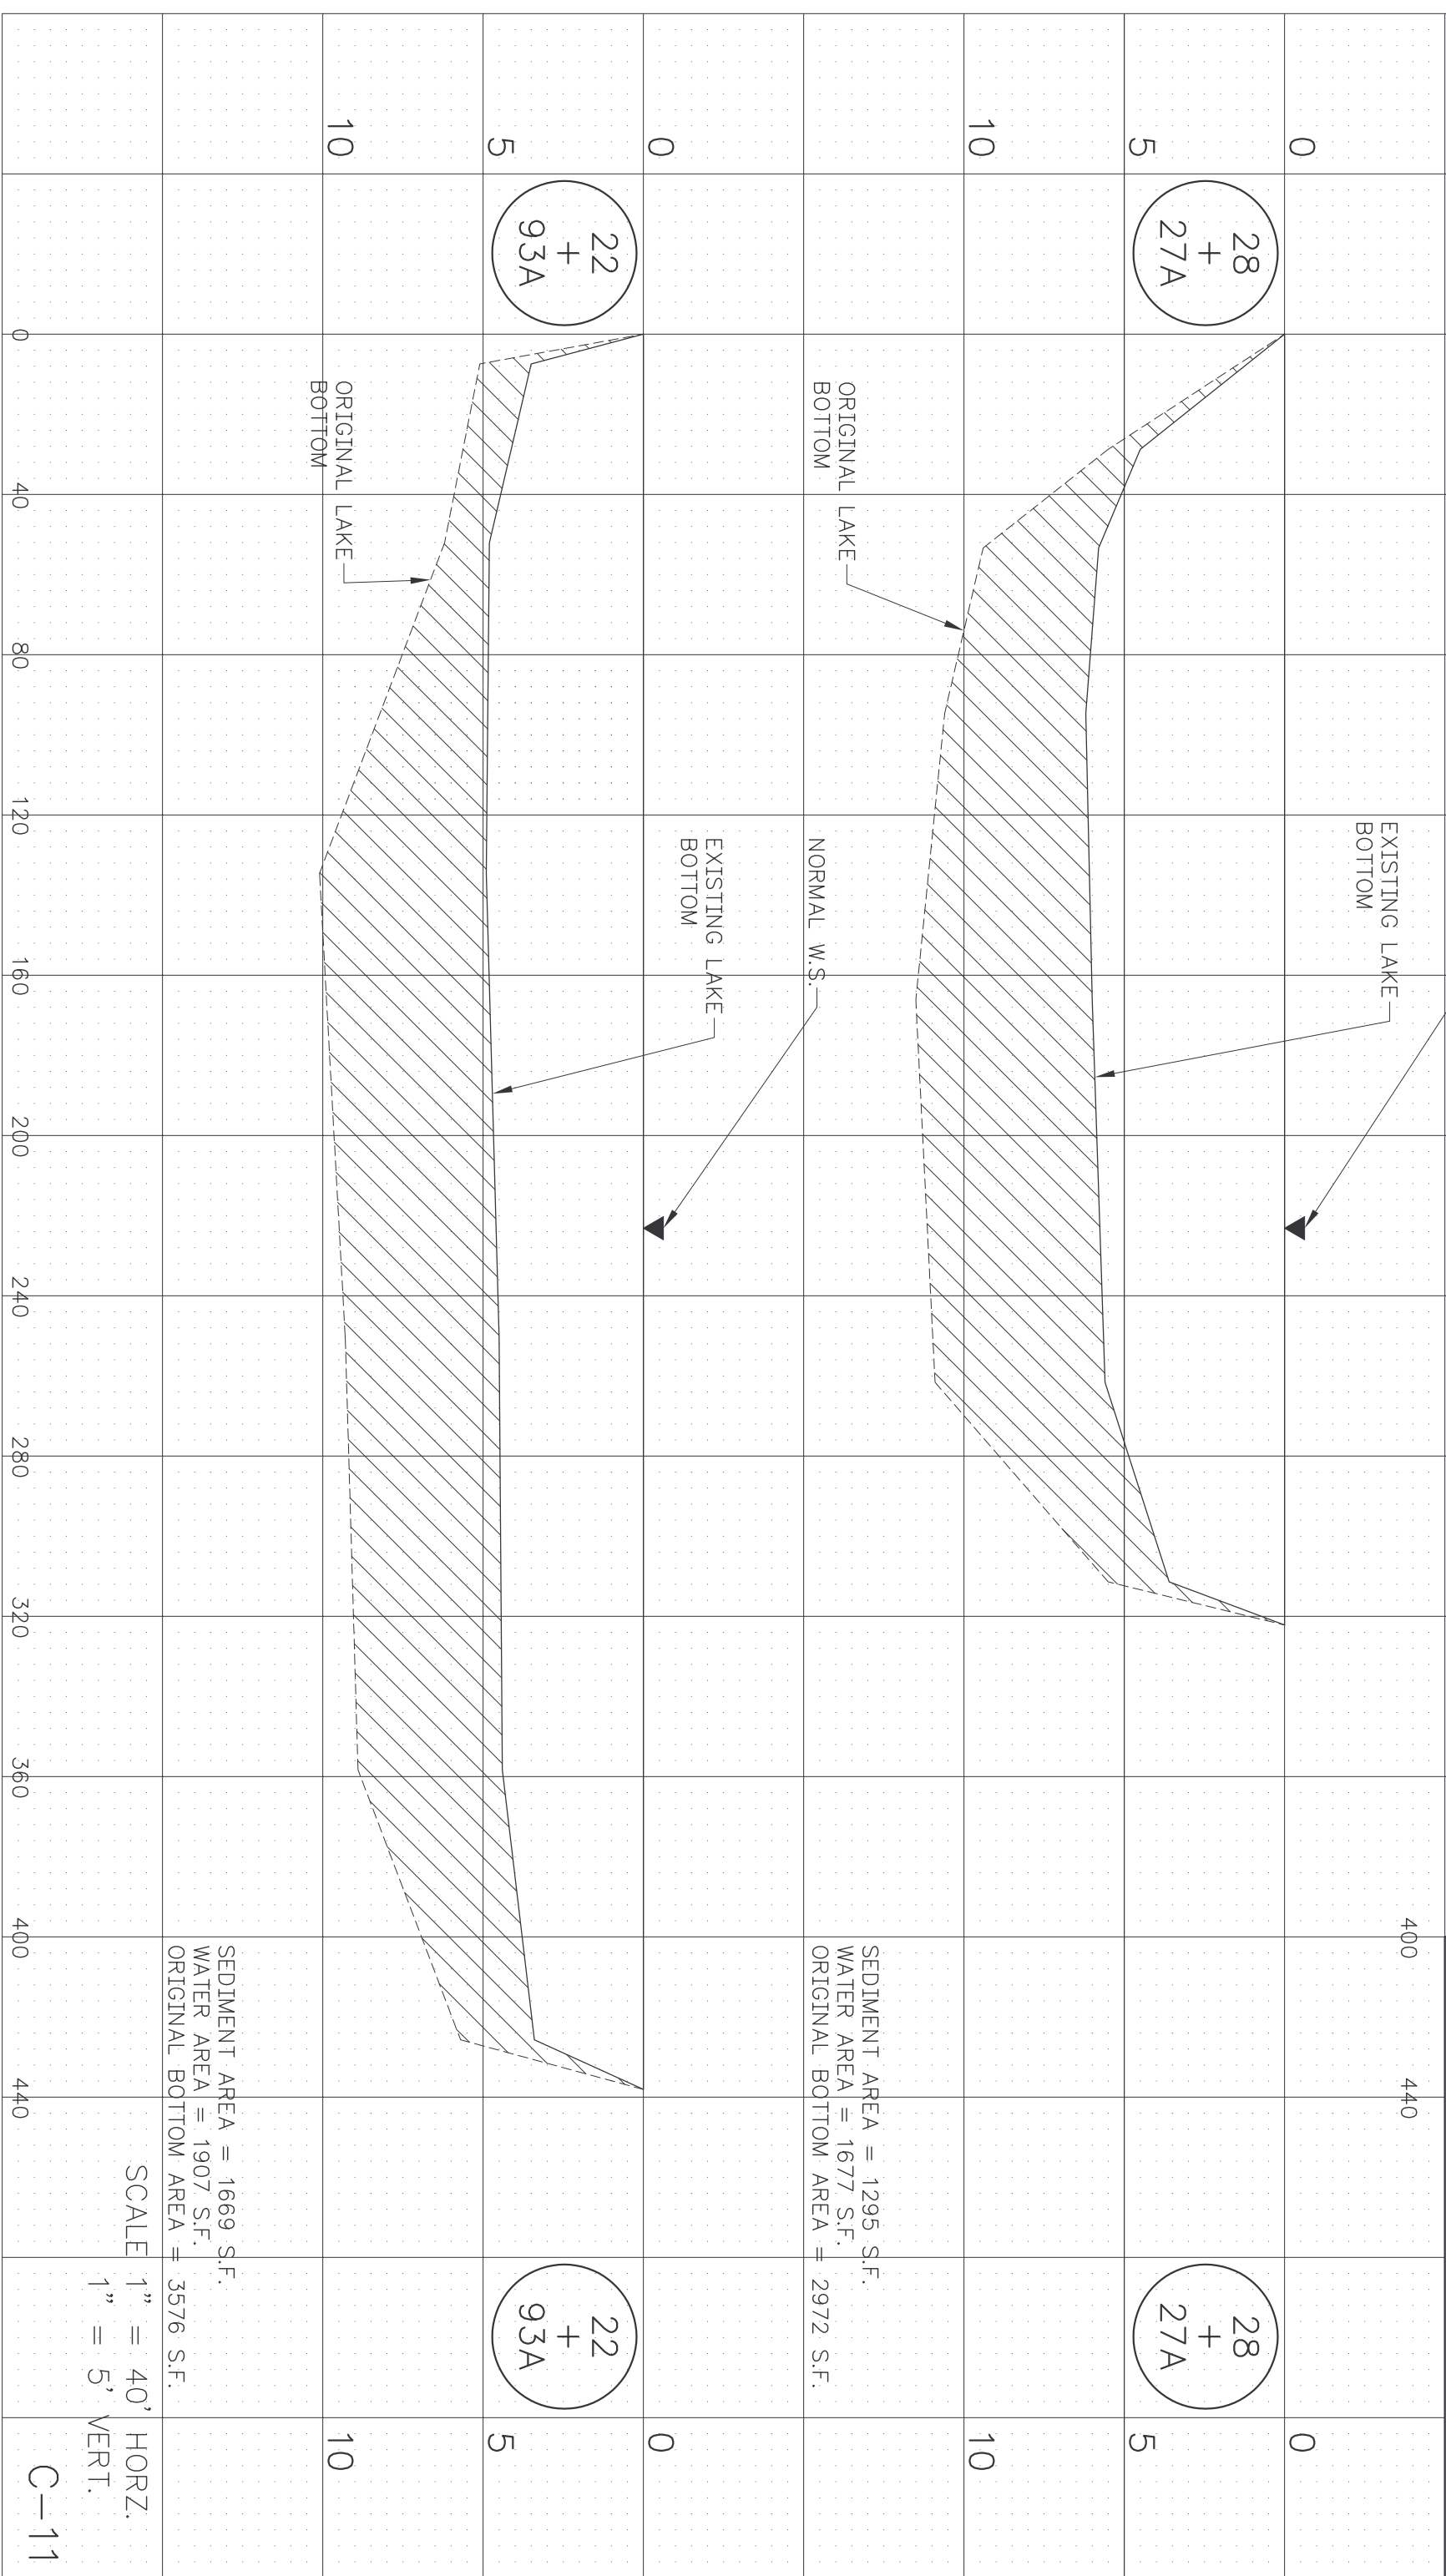
DUNLAP LAKE
 CROSS SECTIONS
 STA. 22+93A TO 28+27A

SEDIMENT AREA = 1295 S.F.
 WATER AREA = 1677 S.F.
 ORIGINAL BOTTOM AREA = 2972 S.F.

SEDIMENT AREA = 1669 S.F.
 WATER AREA = 1907 S.F.
 ORIGINAL BOTTOM AREA = 3576 S.F.

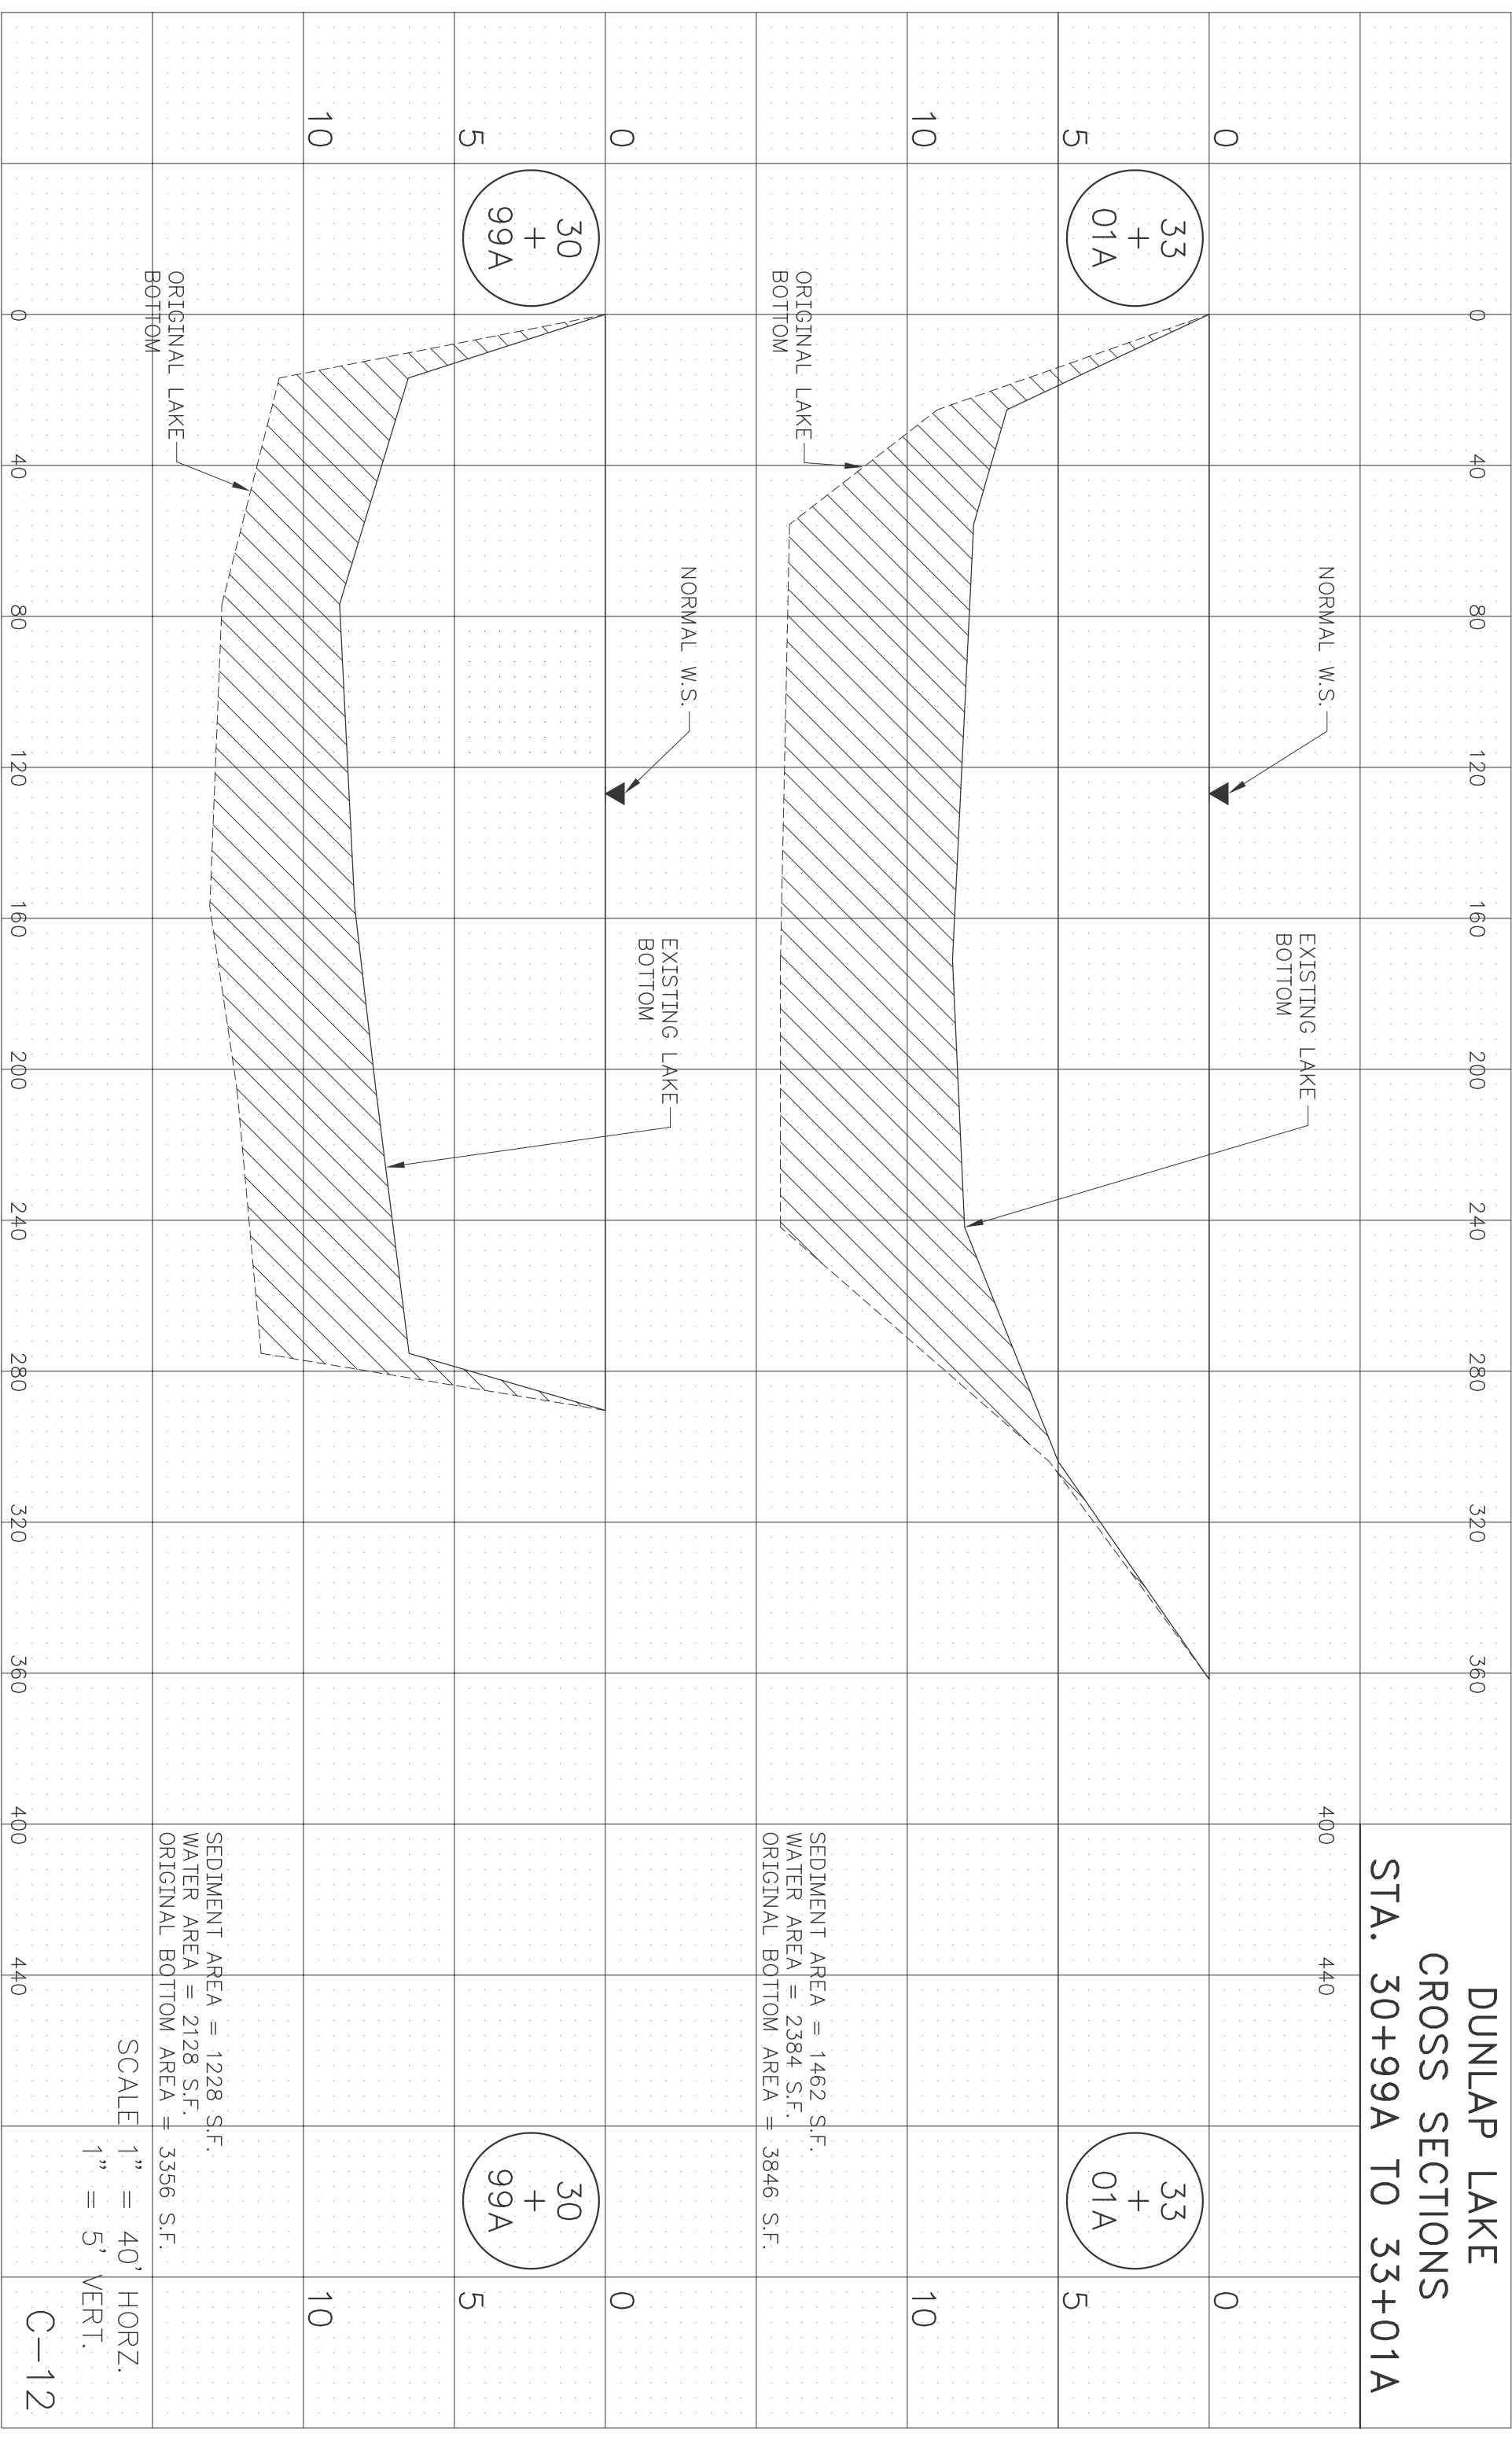
**DUNLAP LAKE
CROSS SECTIONS
STA. 30+99A TO 33+01A**

SEDIMENT AREA = 1462 S.F.
WATER AREA = 2384 S.F.
ORIGINAL BOTTOM AREA = 3846 S.F.

SEDIMENT AREA = 1228 S.F.
WATER AREA = 2128 S.F.
ORIGINAL BOTTOM AREA = 3356 S.F.

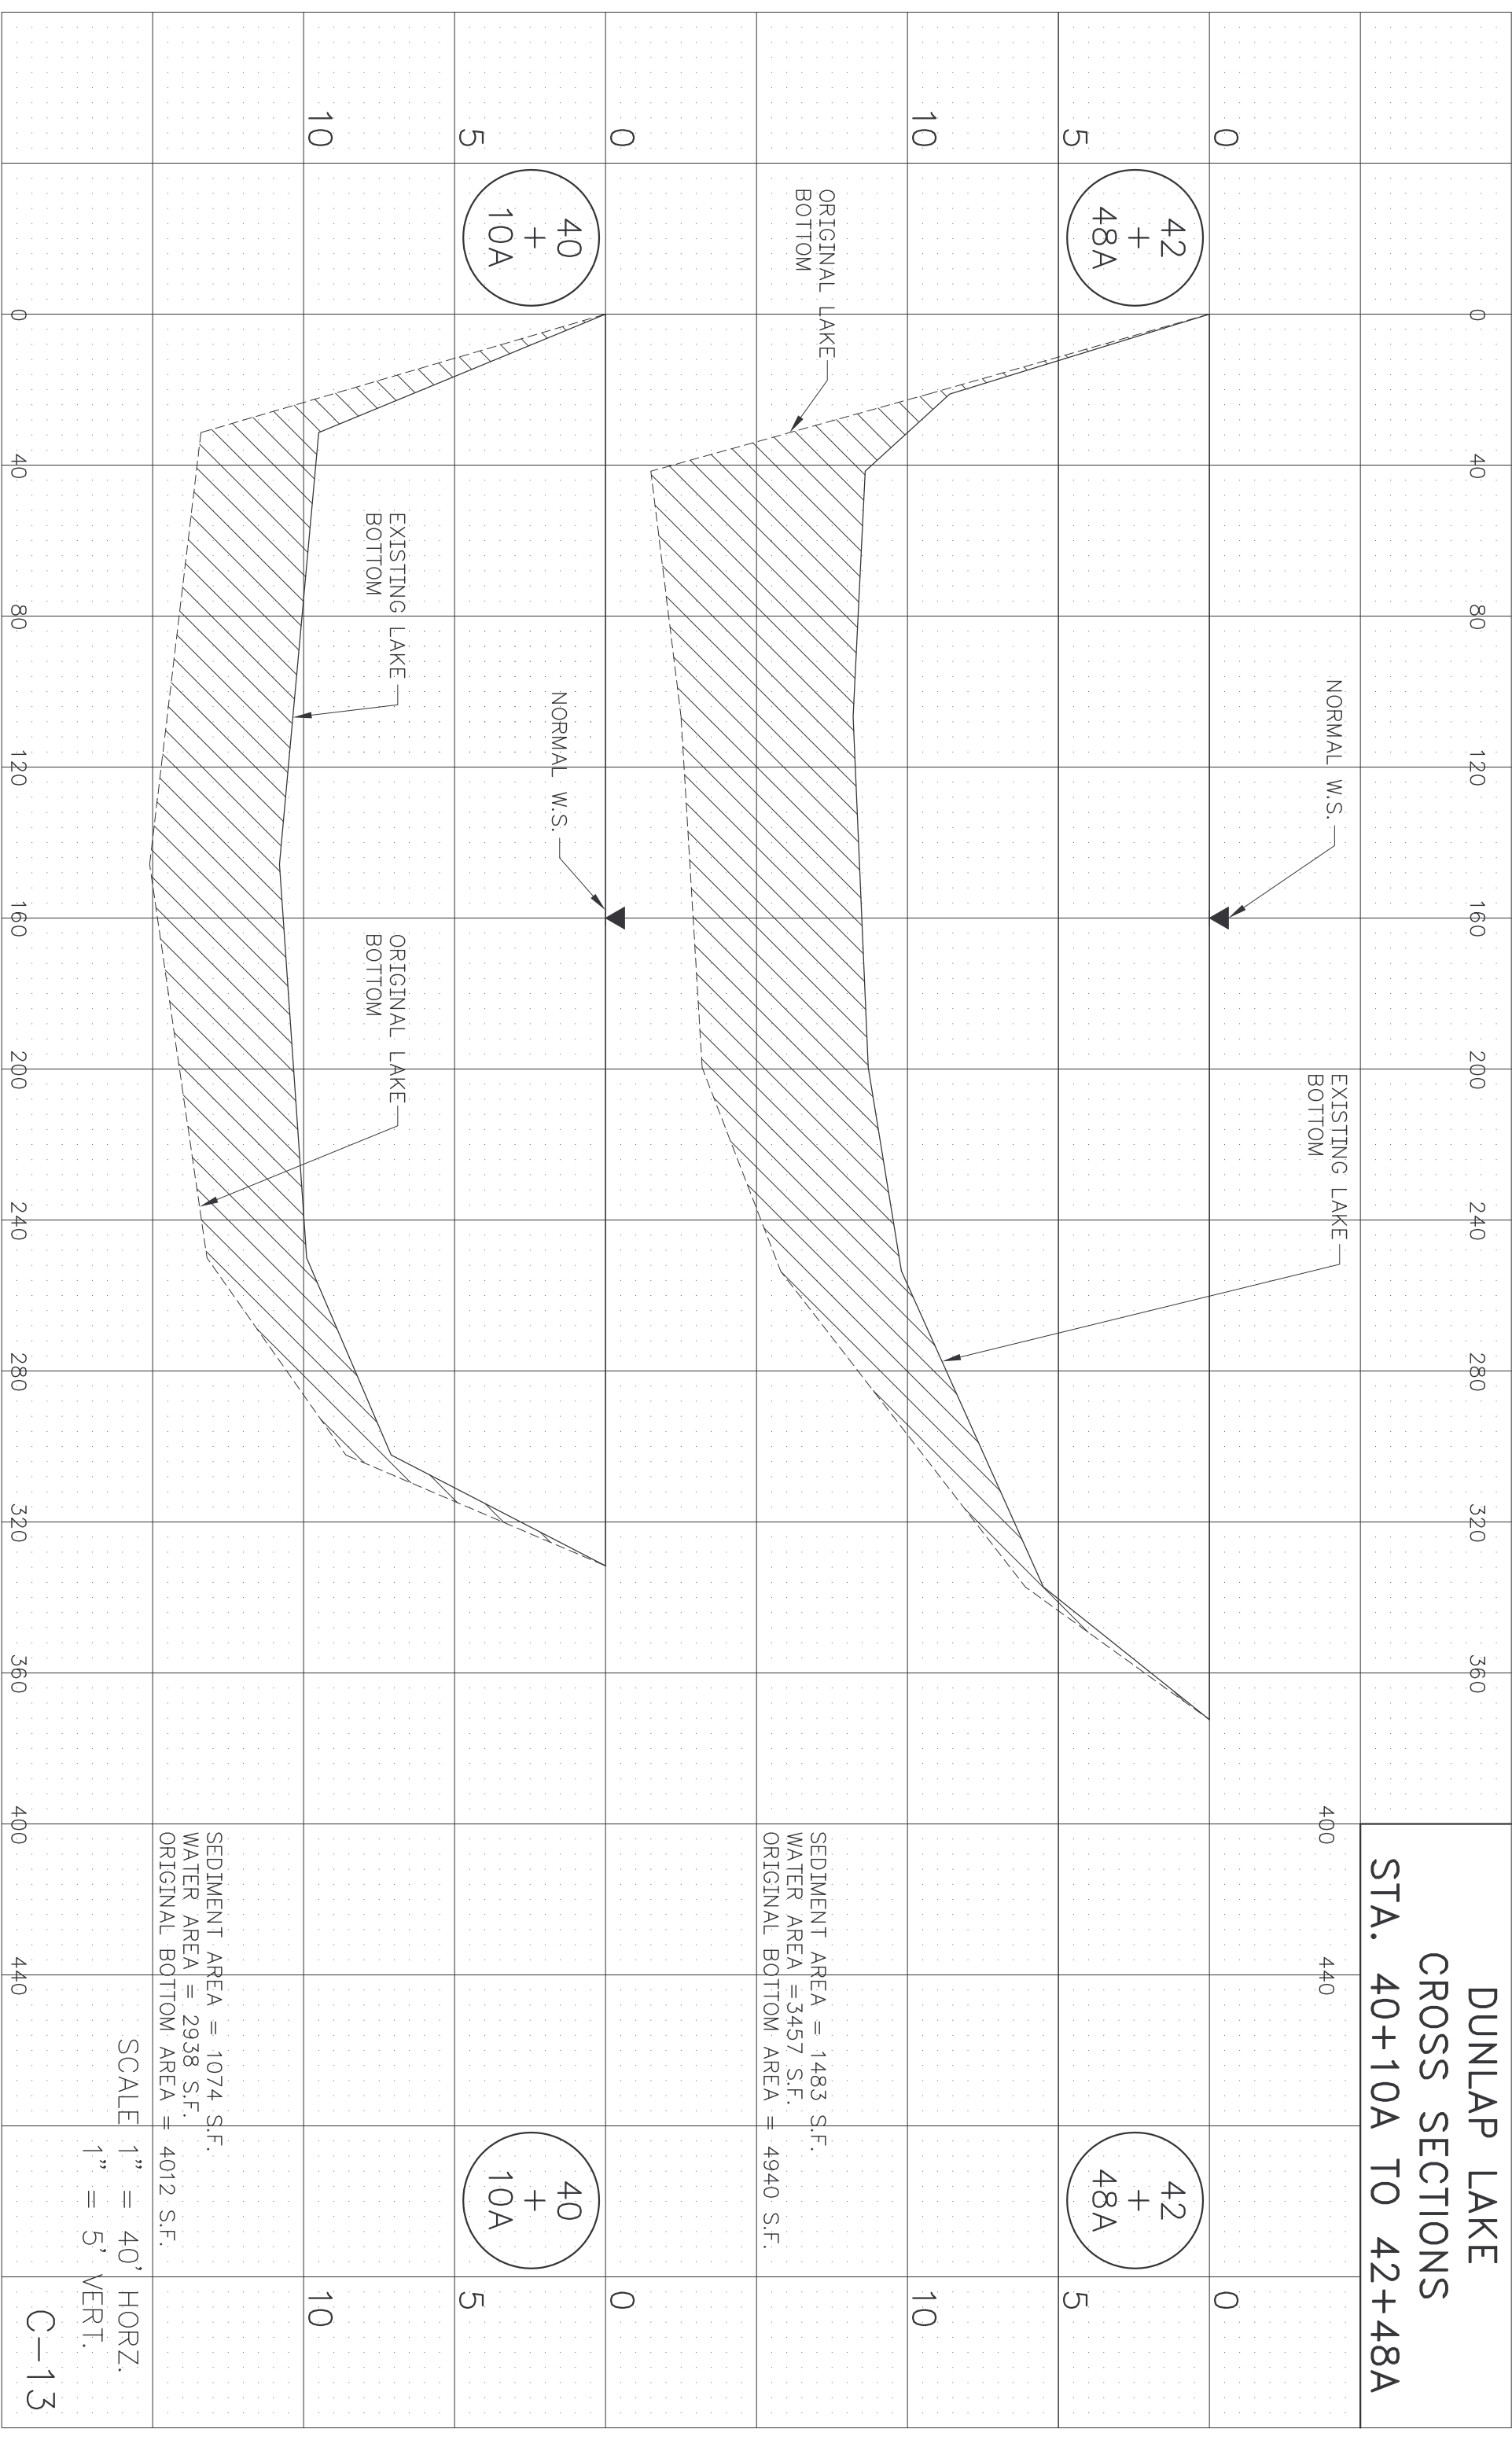
DUNLAP LAKE
 CROSS SECTIONS
 STA. 40+10A TO 42+48A

SEDIMENT AREA = 1483 S.F.
 WATER AREA = 3457 S.F.
 ORIGINAL BOTTOM AREA = 4940 S.F.

SEDIMENT AREA = 1074 S.F.
 WATER AREA = 2938 S.F.
 ORIGINAL BOTTOM AREA = 4012 S.F.
