Dunlap Lake Watershed Study and Lake Management Plan

(prepared for the Dunlap Lake POA)

(Draft Submittal – 1/26/05)

Cochran & Wilken, Inc.

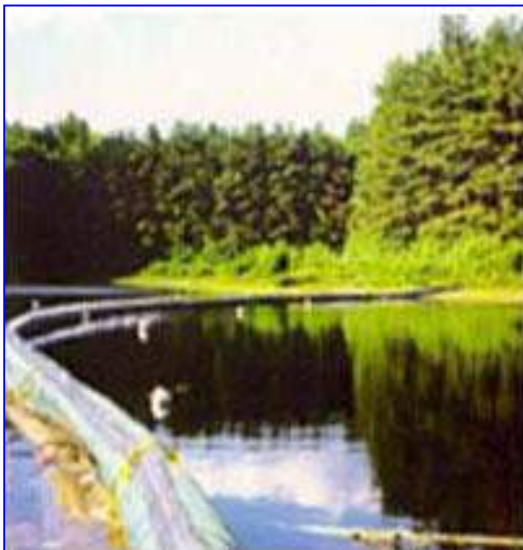
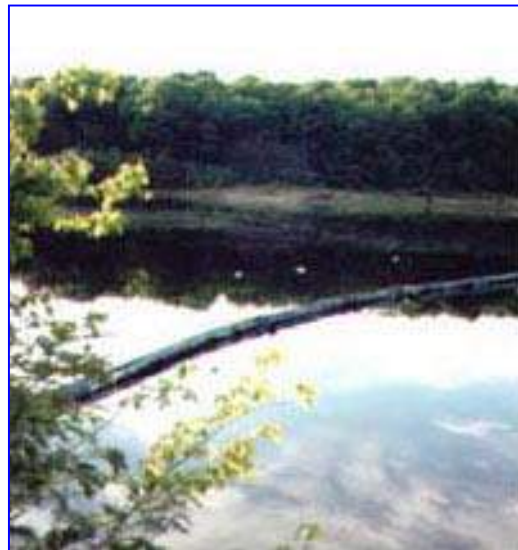
Typical Floating Silt Control Curtains (Gunderboom, Inc.)

The most feasible BMPs to implement are those located on DLPOA owned land. A floating curtain or barrier could be installed within sub-area “C” of Dunlap Lake near the culvert that discharges runoff from the Oaks detention basin outlet structure. This “turbidity curtain” would help diminish flow velocities and would enhance sediment deposition to be confined in a localized area near the culvert. Attached at the shoreline, the curtain would extend across the water’s surface and would extend downward and anchored to a depth of approximately one to two feet off the bottom.

The same type of floating silt control curtain could also be placed at the upstream end of sub-area "D" (see Figure 9). A silt control curtain was not found to be necessary at the upstream end of sub-area "B" due to the minimal volume of sediment measured at cross section 1+68B. Each of these 100 ft. long floating curtains could be acquired and installed for approximately \$5,000 to \$8,000 including engineering selection and assistance. Maximum sediment trapping effectiveness of the floating curtain would be obtained after all sediment has been removed from the semi-confined area. Gunderboom Corporation has an excellent product known as the Particulate Control System (PCS) and is recommended.

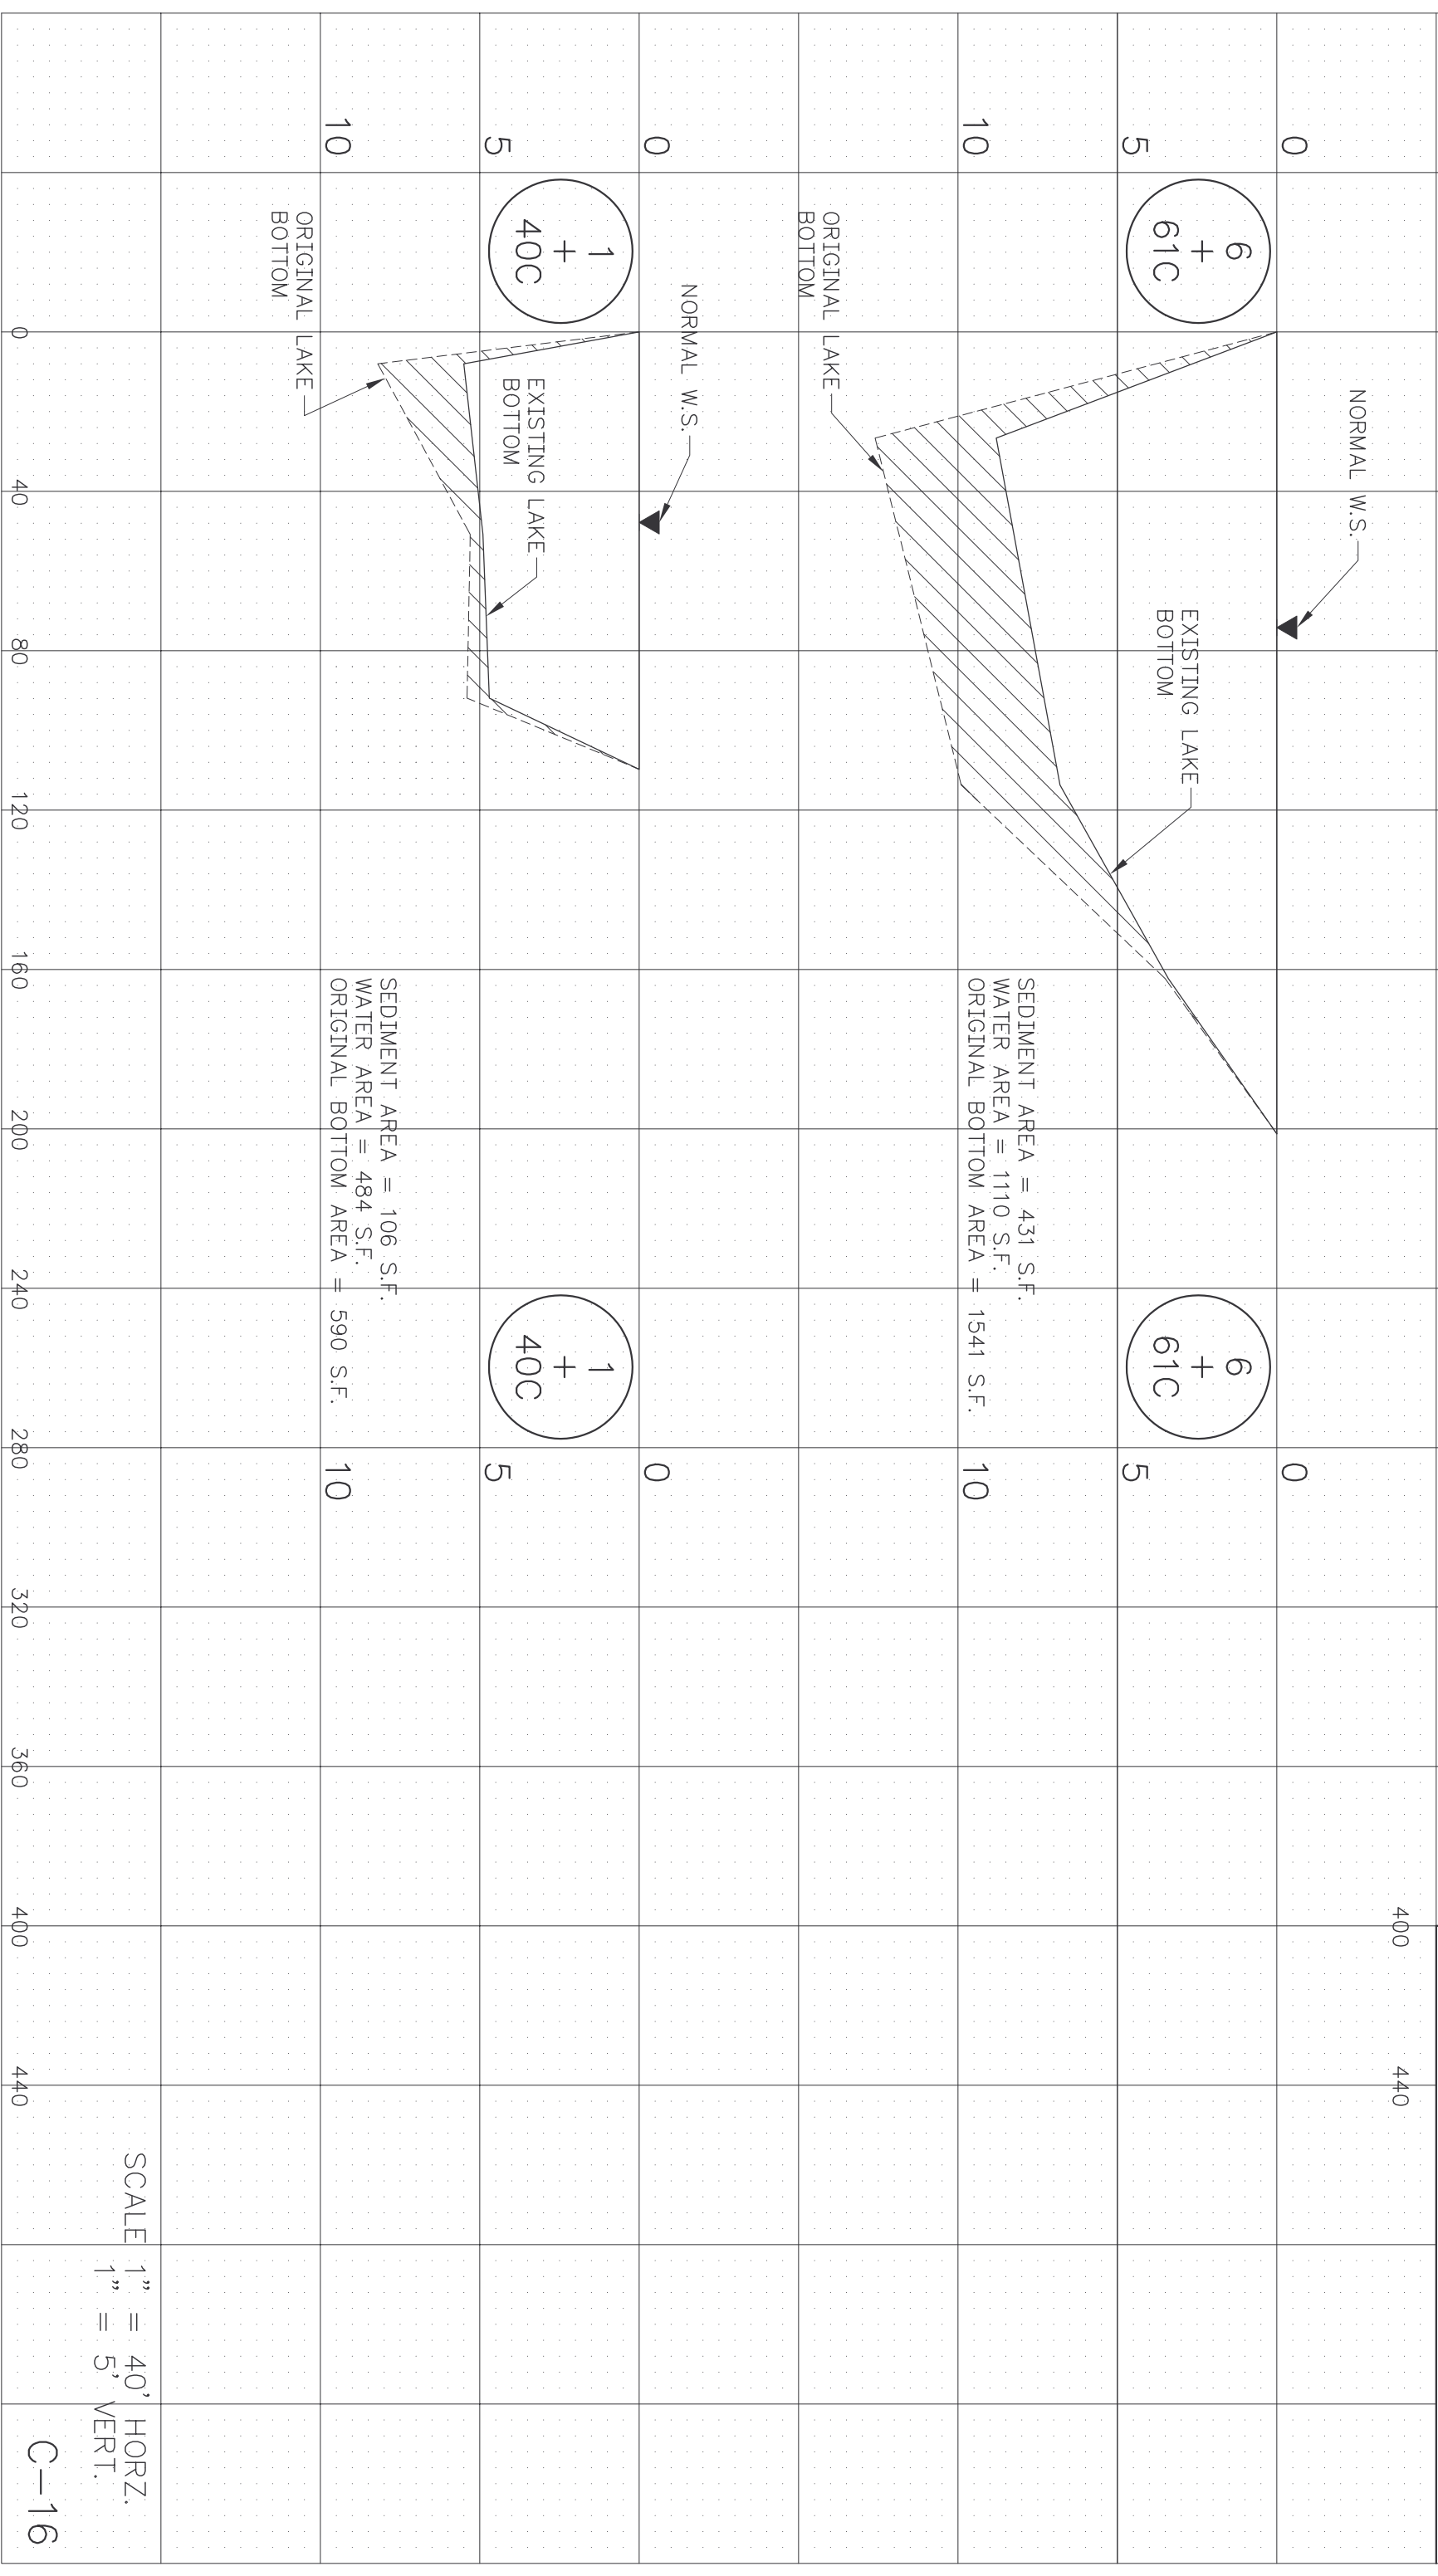
**DUNLAP LAKE
CROSS SECTIONS
STA. 1+40C TO 8+61C**

The C-1 sub-watershed is approximately 92 acres (3.5 percent of the total watershed) and drains into sub-area “C”, which is the east inlet near the north end of the lake. According to the survey cross sections, it was determined that the impacted area in sub-area “C” was limited to lake segments 25 through 26, where approximately 24.7 percent of the original water storage capacity has been lost and 5,456 cubic yards of sediment have been deposited. Since the maximum water depth at Section 06+61C (downstream end of impacted area) was found to range from 7.0 to 9.0 feet with sediment depths of 3.0 to 4.0 feet, it has been estimated that the impacted area extends approximately 200 feet into segment 27. The estimated sediment volume in the partial lake segment 15 is approximately 3,193 cubic yards. Therefore, the total estimated sediment volume in the impacted area of sub-area “C” is 8,648 cubic yards.
